# A Case Study: Successfully Managing Excessive and Rapid Slope Deformation in an Open Pit Mine Utilizing Slope Monitoring Radar Systems

## ABSTRACT

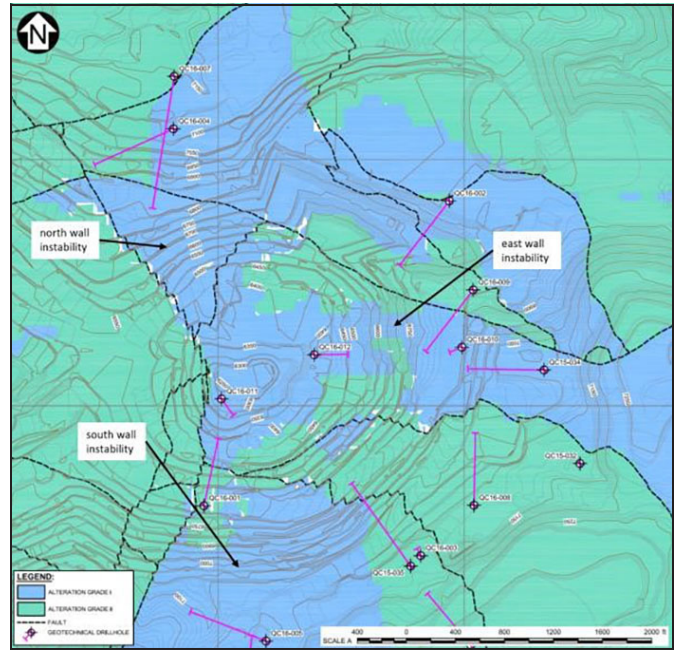
The rock mass domains of the pit are comprised of six main lithologies and two alteration grades. The six units include porphyry (intrusive), limestone, sandstone, shale, rhyolite (volcanic), and fault zones. Significant degradation of the rock mass quality and strength are attributed to phyllic, argillic, potassic, propylitic, and gossan alteration or Grade (i), with examples shown in Figure 1. The second alteration Grade (ii) has little adverse impact on the rock mass quality or strength and represents unaltered rock. Figure 2 illustrates the alteration grades and known faults in the 2016 open pit (Yong, et al 2022).

**Figure 2. Map of the entire pit indicating the two different alteration grades (Yong, et al, 2022).**

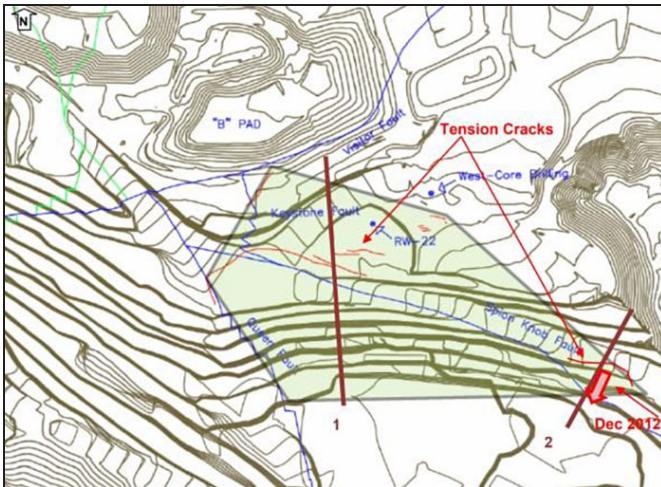
By late 2012, tension cracks were observed in a haul road located directly above the north wall. A dewatering well also had to be abandoned in the area due to the ongoing slope deformation. Slope monitoring radar registered that the northern wall had an average velocity of about 2 inches per day.

**Figure 3. Topographic map of the 2012 northern wall, with indications where tension cracks were observed (Yang, 2013).**

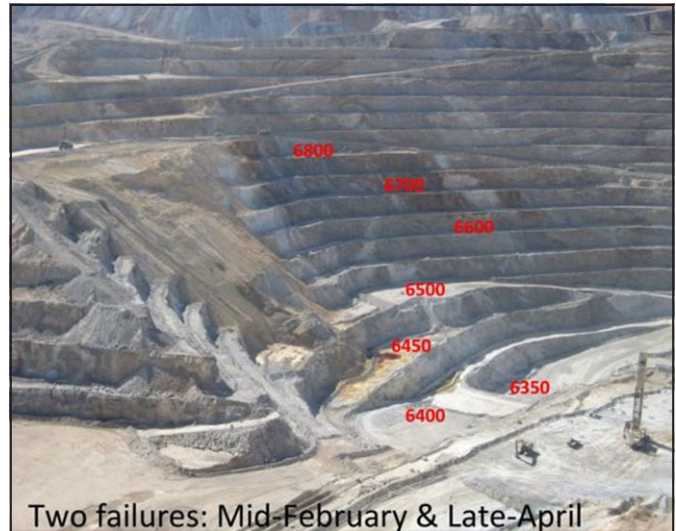
In February 2015, a slope movement occurred on the eastern wall of the pit due to high pore water pressures, saturated toe, and very weak rock masses. The mine initially mitigated the area by dozing down the loose material, but the mass had eventually shifted again by April of the same year.

**Figure 4. Photograph showing the high-wall movement on the eastern side of the pit (Yang, 2015).**

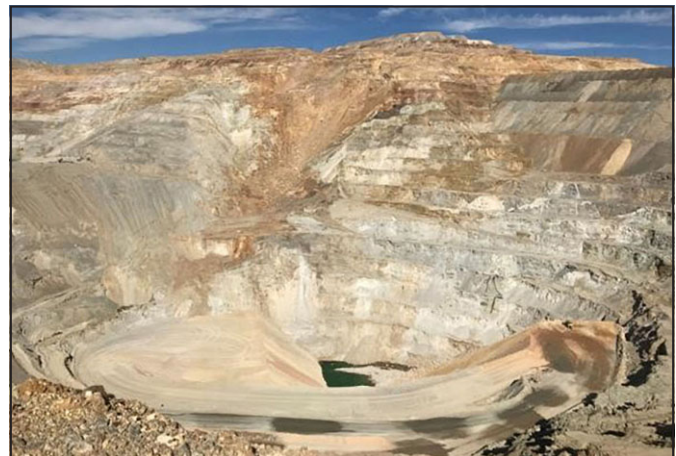
In 2016, the mining sequence resulted in the necessary placement of a haul road across the northern wall instability, with mining activities also being held at the toe of the same wall. During this year, the northern wall displaced approximately 300 feet, created a scarp of about 150 feet in height, and had ongoing average velocities that ranged from 4 to 33 inches per day. This amount of movement became too much for safe access, and mining activities were temporarily halted in the pit by the end of 2016.

**Figure 5. Photograph of the northern wall taken in 2020. Backfilling operations were started to buttress against further movement.**
