A Surface Geotechnical In-Pit Underground Portal Relocation: An Operations-Based Case Study

Russell J. Sheets

Barr Engineering Co., Bismarck, ND, USA

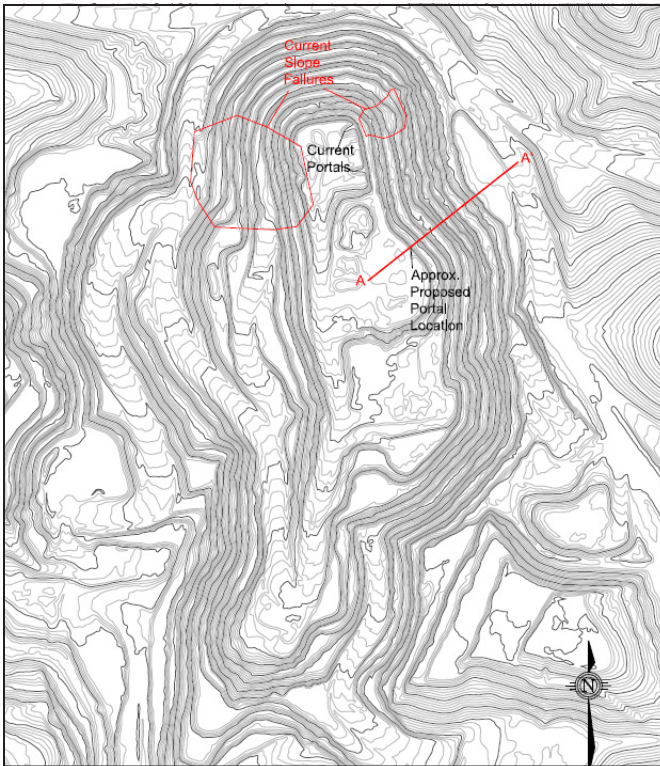
However, in December 2015, slope instability began to develop in the west highwall of the final open pit phase (see Figure 1). A slope failure of the lower extent of the highwall impacted the use of the batch plant. Crest displacement included the pit side outer portion of the haul road/access road into the pit.

Figure 1. Map of the open pit with the on-going slope failures identified in red. The current portal locations are indicated, as is the location of the proposed new portal.

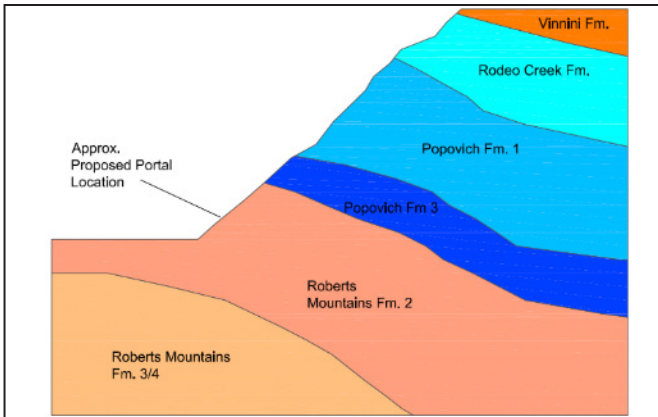
Based on the current surface geology model and mapping information, this area of highwall is primarily composed of: Rodeo Creek Formation, Popovich Formation, and Roberts Mountains Formation. The bedding and formation contacts tend to dip toward the northeast around as observed from exposed pit slopes. Since, the proposed portal location would be located in an area of highwall that trends northwest to southeast, the formation contacts are dipping back into the highwall. Typically, this combination of pit slope and structural intersections lead to a more stable configuration (see Figures 2).

Figure 2. Geologic cross-section through the proposed portal location. There were no major faults according to the geology model; geologic formation contacts are dipping away from the pit toward the northeast.

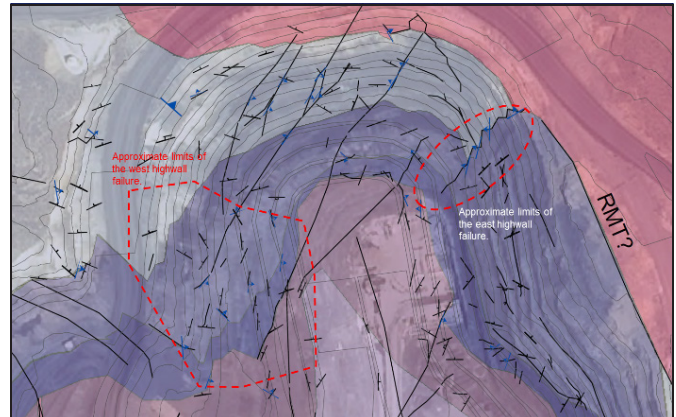
Fortunately, these conditions are different from the geologic conditions that were observed in the north end of the open pit and associated with bounding the ongoing slope failures. The west wall failure had been developing along fault and formation contacts. The contacts between the Rodeo Creek, Popovich, Roberts Mountains Formations are in proximity, with an overall pitward dipping orientation with respect to the highwall. Infiltration from precipitation and surface run-off over time, accelerated deterioration along structures and contacts. The weakening resulted in the instability that began to develop in December 2015. This area is shown in Figure 3.

Similarly, the local failure above the existing portals was occurring along a modeled fault structure that is also the contact between the Rodeo Creek and Popovich Formations. The projection of the fault/contact in the highwall was near vertical above the northern portal. Failure along this structure did begin during surface mining activity of the final phase. Over the past several years, the existing failure and weak material along the contact has continued to deteriorate; particularly when there have been winters or springs with above average precipitation. The area is indicated in Figure 3.

Figure 3. Geologic map of the northern end of the open pit. The observed slope failures were controlled by both geologic formation contacts and known faults.

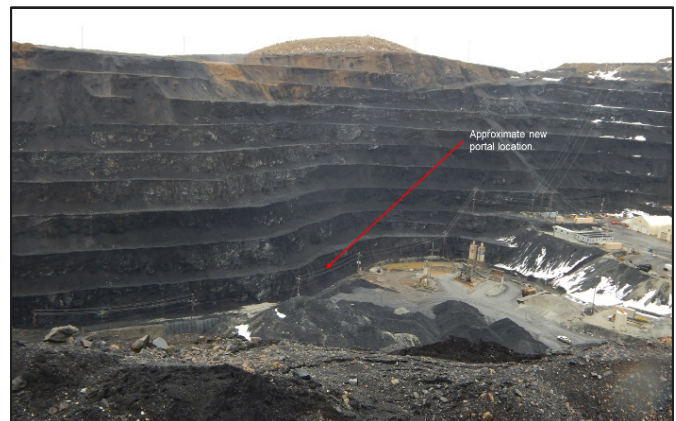
Figure 4. View of the highwall above the proposed portal location. The catch benches contain material along each bench toe; however, there are no signs of slope movement.

instabilities had or were developing. Pictures are included as Figures 4, 5, and 6. The upper two benches do exhibit more substantial deterioration and weathering (Figure 4). This was observed in the Vinnini and Rodeo Creek Formations as surface mining was developing each phase of the open pit. There were some localized failures that were the result of weak material not able to remain stable when excavated at 65-degree bench face angles; however, these had been contained on the existing catch benches.

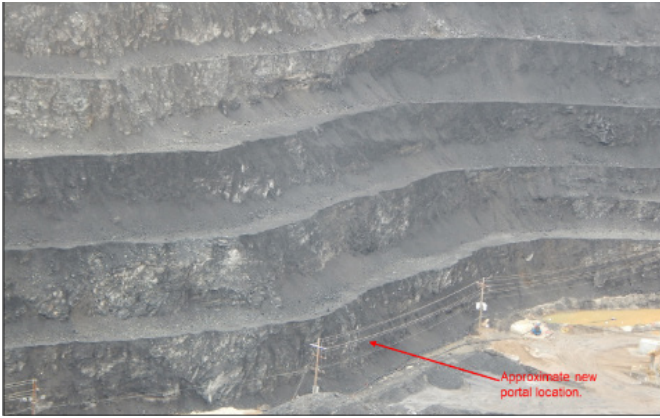
Figure 5. A closer view of the highwall above the proposed portal location

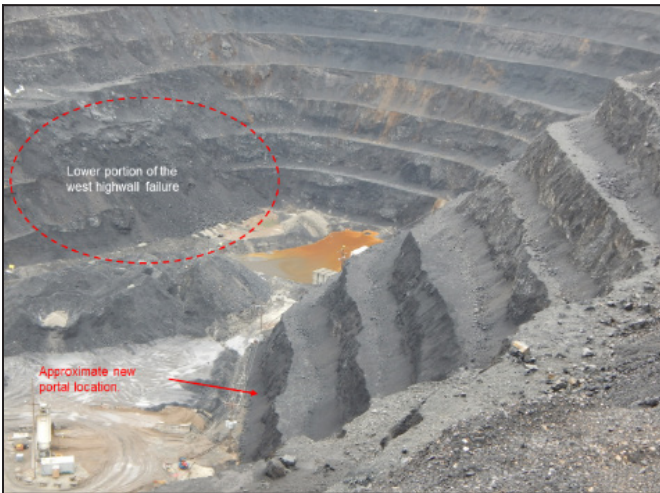
Figure 6. A view looking parallel to the highwall and catch benches above the proposed portal location

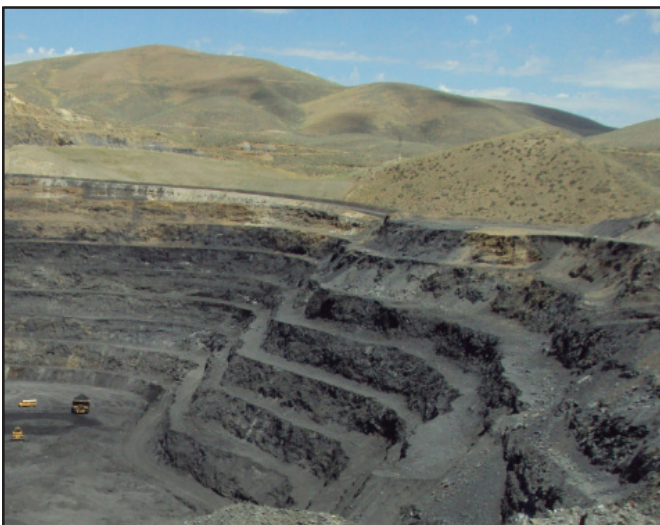
The remainder of the of the open pit slopes had performed very well, considering the local geological and geotechnical conditions exposed in the instabilities. There is, of course, minor ravel and sloughed material that had accumulated at the toe of each bench face; however, when examining photographs of the same area taken in July 2010 (see Figure 7) and January 2011(see Figure 8); it does appear that most of the material accumulated either during

Figure 7. A July 2010, photograph that shows the upper benches of the highwall above the proposed portal location

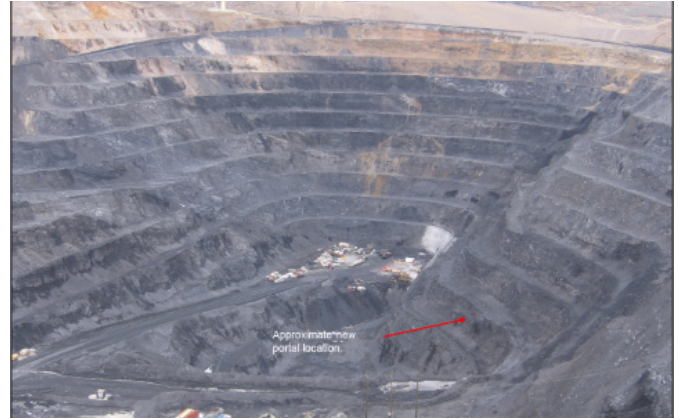
Figure 8. This January 2011 photograph shows the highwall above the proposed portal location. Development of the existing portals has commenced in the northern end of the pit.

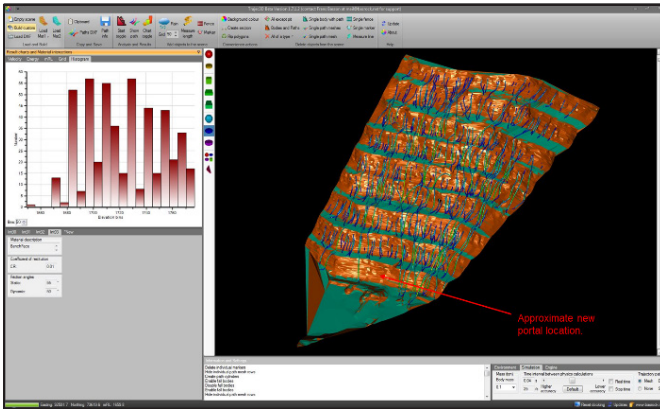
Figure 9. Three dimensional rockfall analysis conducted on the existing highwall geometry

Two model scenarios were evaluated. The first evaluated the condition of the open pit slope in its current condition at the time of the assessment; these results are depicted in Figure 9. The second analysis was conducted with a 3-ft barrier (berm or fence) along the crest of the catch bench immediately above the proposed portal. This allowed a comparison of the estimated rockfall events that could be retained above the portal and surrounding area, which is shown in Figure 10, with the results of the current condition analysis.

- A total of 14 rockfall events could reach the floor/toe of the open pit slope ($14/500 \times 100\% = 2.8\%$) for the existing conditions.
 - Most of these events occurred at the southern extend of the proposed portal area, where back break during active surface mining reduced the catch bench width and allowable containment.

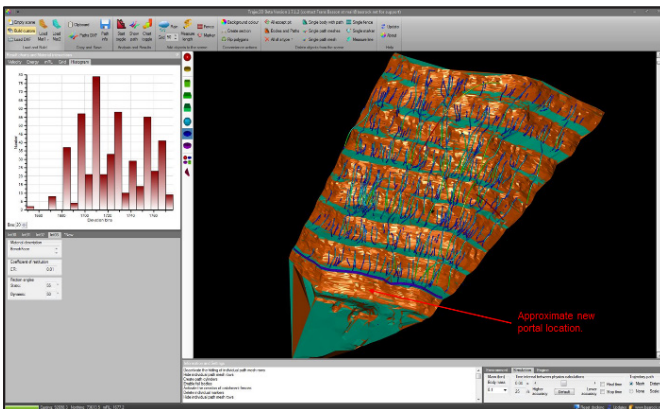
Figure 10. Three dimensional rockfall analysis conducted on the current highwall geometry with a 3-ft barrier along the crest

- A small barrier (i.e., berm) constructed along the bench above the portal mitigated all modeled rockfall events from reaching the floor/toe of the highwall.
