Principal Horizontal Stress Contributing to Massive Roof Collapse at the Subtropolis Mine

ABSTRACT

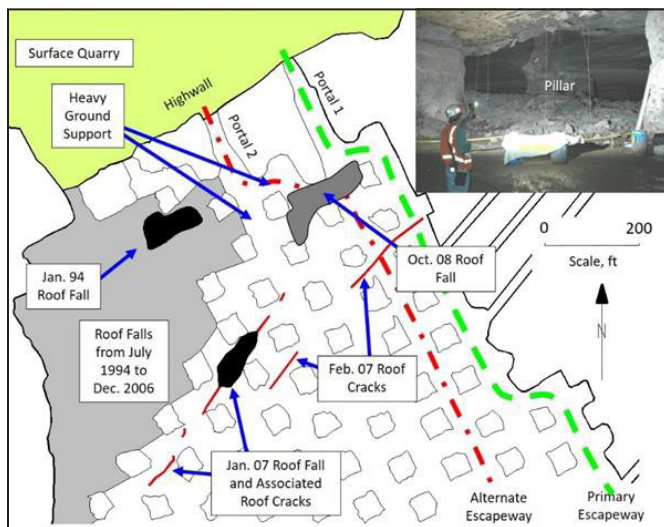
Safety and Health (NIOSH) Lake Lynn Research Facility which occurred slowly from 1994 to 2006 (Figure 1). The cause of the Lake Lynn massive roof collapse has been studied and several factors are suggested including weathered joints, inadequate caprock thickness, exceedingly weak strata above the caprock, strata dips that favor strata extension into the adjacent surface quarry, freeze-thaw action in the entries near the highwall, and a lack of adequate support.

Figure 1. Location and dates of massive roof collapse at the Lake Lynn Laboratory from 1994 to 2007

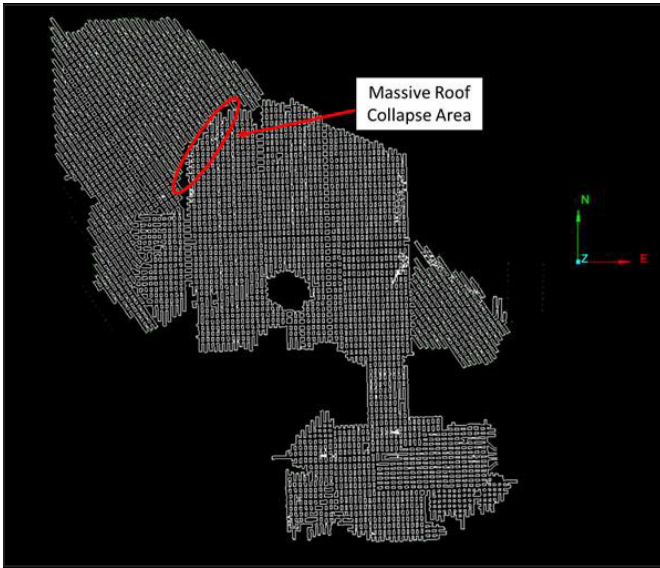
The massive ground collapse at the Subtropolis Mine in Petersburg, OH, is also defined as a massive roof collapse. The failure of the roof began in late 2015 and has slowly developed over time and now encompasses several entries in the north-central part of the mine (Figure 2). The Subtropolis Mine, which is a room-and-pillar mine that extracts the Vanport Limestone, has a long history of reacting to horizontal stress damage in the roof. Since the mine opened in 2005, the operators have changed the orientation of the mine several times in order to alleviate the detrimental effects of high horizontal stress and to determine the principal horizontal stress direction (Figure 3).

Figure 2. Subtopolis Mine Map with massive roof collapse area circled in red

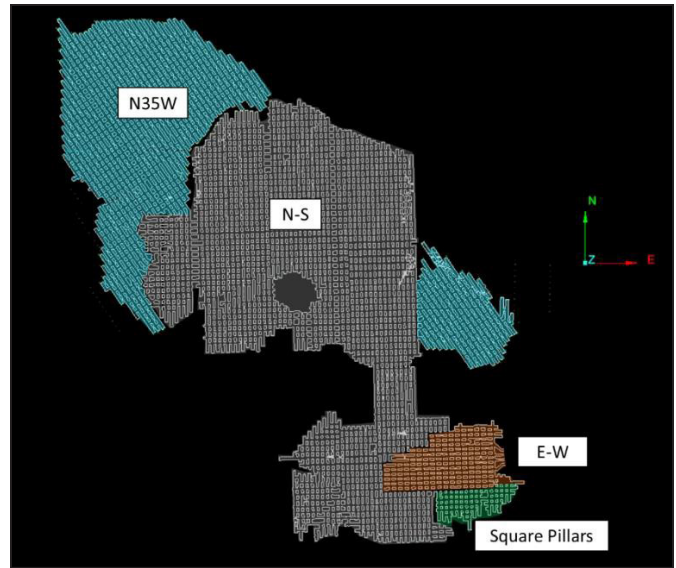
Typically, a mine will find the orientation of the principal horizontal stress at or near to the regional horizontal stress. At the Subtopolis Mine, the principal horizontal stress differs from the regional horizontal stress and can even differ across the mine itself. Evidence to support these changes in the principal horizontal stress direction come in the form of cutter roof failures and oval-shaped roof falls oriented in different directions in specific areas of the mine. The principal horizontal stress direction at this mine tends to be generally N35W.

Figure 3. Subtopolis Mine Map with varying heading orientations

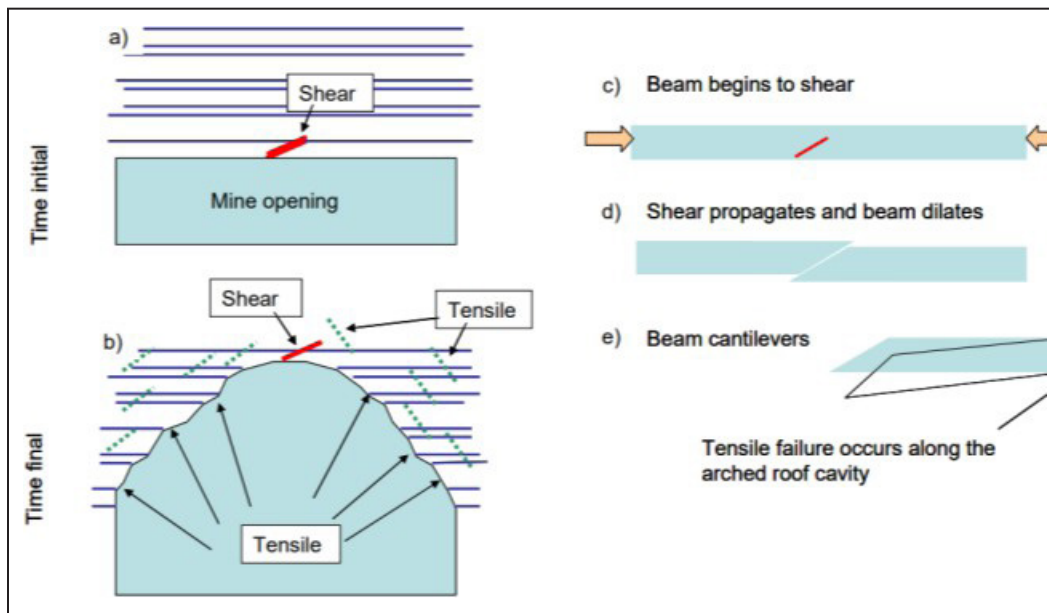
Figure 4. Generalized sequence in which individual roof beams fail and develop into large roof falls under elevated horizontal stress conditions (Iannacchione et al., 2005)

Failures appear to originate in the lowest beams, or the beams closest to the mine opening due to the concentration of stresses in the lower beam and constraints to bending in the upper beams (Iannacchione et al., 1998). Therefore, failure begins with a shear in the first foot of the caprock. Shear failures appear as low- angle ruptures in the rock with a kind of “rock flour” along the newly created surface (Iannacchione et al., 2019). Then, the shear propagates, and the beam begins to dilate. Next, the beam begins to cantilever, causing tensile failure along the boundary between the roof and the pillar. Once the beam fails completely, the shear failure propagates to the next layer. In other mines the shear failure continues to propagate upwards through the roof layers until the fall has developed an arch shape. However, at the Subtropolis Mine there are very weak shales present above the caprock. Here, once the caprock fails, the fall takes on a chimney shape and, in some cases, extends approximately 30 ft into the roof.

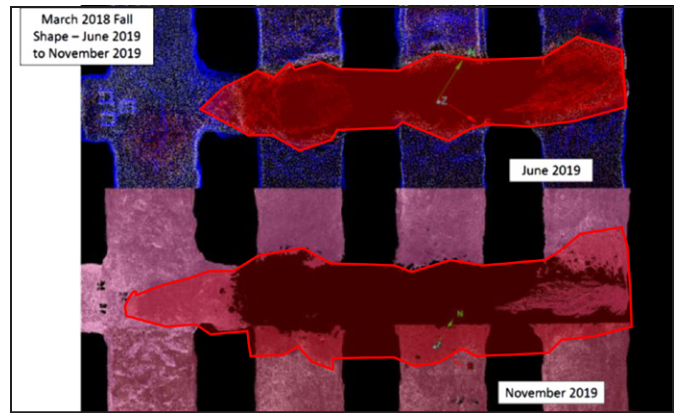
Figure 5 shows 3D LiDAR scans capturing the shape of this type of fall and its growth over time (shown in red). In this roof fall, the failure extends approximately 30 ft into the roof and up into the overlying coal seam. The shear failure orientations are parallel to the long axis of the elliptical-shaped cavities in this case study. All of these damages have been captured using detailed geologic mapping and, in some cases, 3D LiDAR scanning. For example, Figure 6 contains two photos from the Subtropolis Mine. Photo A is an example of a dilating beam and Photo B shows shear failure in three separate fully-grouted bolts from the same area.

Figure 5. March 2018 roof fall in XC02 progression from June 2019 to November 2019

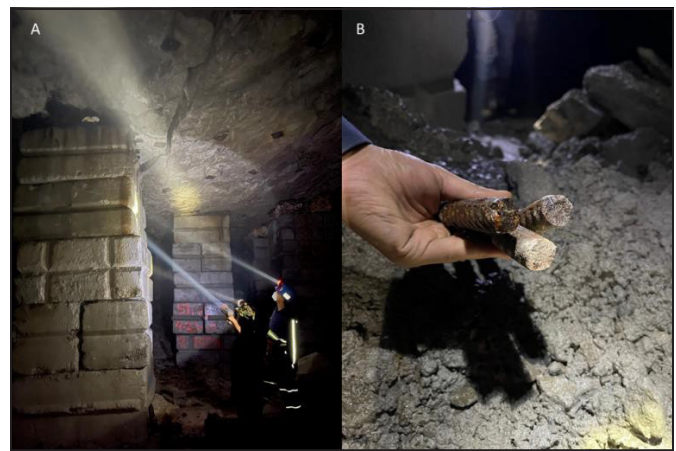
Figure 6. A) Photo of shear failure in roof and B) Photo of sheared bolts

The operator noticed that these types of failures in the N-S entries appear to concentrate at the northwest and southeast corners of the pillars. In order to minimize the number of these types of roof failures, the mine utilized the stress control layout. The stress control layout utilizes the headings in the principal horizontal stress direction. This minimizes damage to the headings but concentrates damage into the crosscuts. To minimize damage to the crosscuts, the mine has implemented the use of rectangular pillars. The mine also has implemented a secondary bolting strategy and included windows in every other crosscut. According to Evanek et al. (2020), “Windows are used to resist horizontal movements or deformation that occur parallel to the maximum horizontal stress direction or perpendicular to the direction of stress failures. A window is developed by leaving an increased thickness of roof rock in the crosscuts, thus reducing the crosscut dimensions

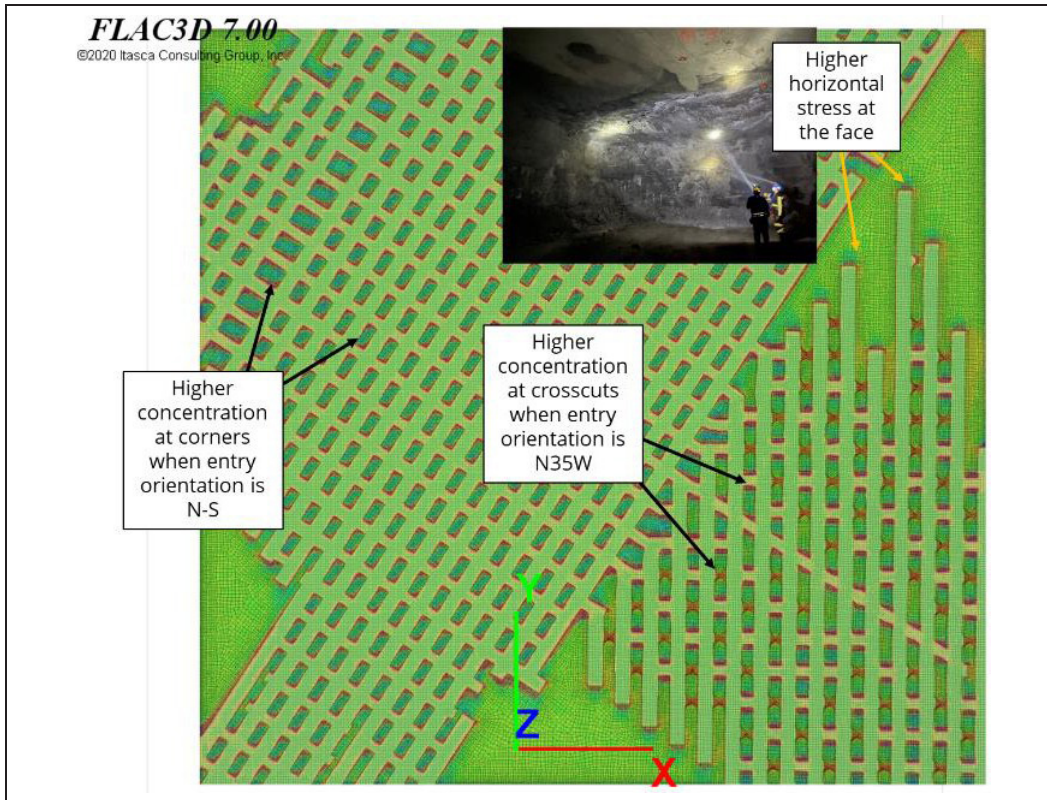
vertically.” The first time the stress control layout was implemented at the mine was in the northwestern region of the mine in 2018, on the other side of the massive collapse area. Numerical modeling was utilized in this study to confirm damage patterns seen at the mine. The model, as seen in Figure 7, maps the distribution of the maximum principal horizontal stress over two different mine layouts at Subtropolis. The principal horizontal stress in this model is parallel to the Y-axis in the figure at N35W. The pillars with a N-S orientation show a higher concentration at the corners of the entry (indicated by red), which aligns with damages mapped underground. The pillars oriented parallel to the principal horizontal stress at N35W show damage (indicated by red) being concentrated at the crosscuts and not in the entries. This damage concentration has also been mapped at Subtropolis and also confirms the stress control layout is working as planned.

Figure 7. Model of distribution of maximum principal horizontal stress

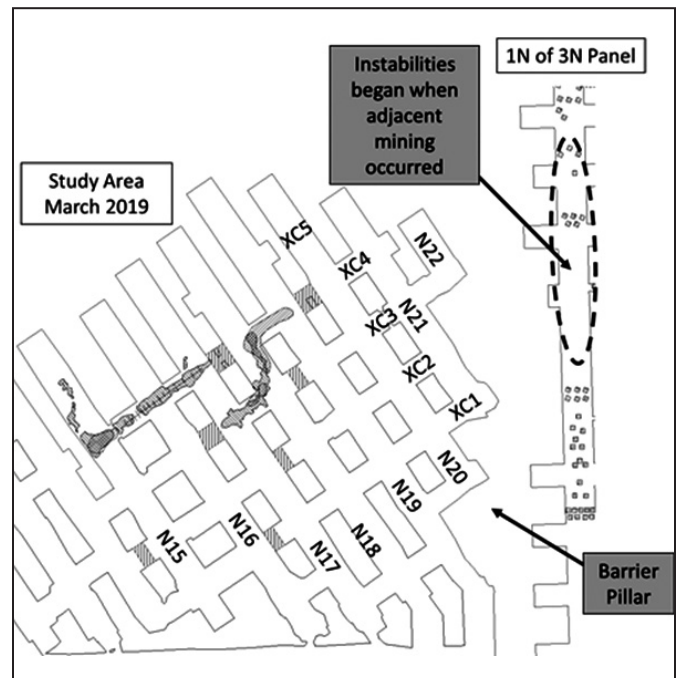
In 2015, a massive roof collapse at Subtropolis Mine began to form in the northwestern portion of the mine. From April of 2016 to the end of 2018, the collapse area had been relatively quiet. However, in 2019, mining began to extend close to the old workings where the collapse had occurred. Instabilities began to form again, and the size of the collapse began to grow. In addition to its growth in the old workings, new damages began to “jump” into the new workings, causing a major roof fall in one of the crosscuts nearest to the old workings and with the lowest caprock thickness (Figure 8). Since mining moved further from the edge of the collapse area, damages were expected to stop. However, due to the presence of horizontal stress at this mine, the collapse has not stopped progressing further into the roof and outward into the open entries. The operator had witnessed the role horizontal stress played in the collapse. Damages progressed slowly as cutters began to run from east to west from the collapse area and the operator was able to follow the shifting of the test holes as it went. 3D LiDAR scanning was able to capture some of these changes over time.

Figure 8. a1N of 3N Panel location in relation to mining in 2019 (Evanek et al., 2020)

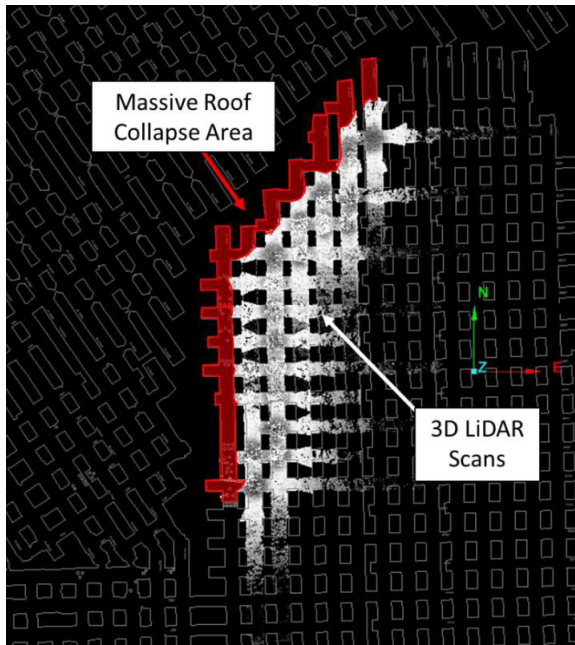
Figure 9. 3D LiDAR pointcloud ariel image of massive roof collapse

Baseline 3D LiDAR scanning of the collapse area was conducted in July of 2022. Scans were captured using the Maptek I-Site 8200 stationary scanner, and 360-degree scans were collected at each entry and crosscut along the collapse area approximately 50 ft apart. Each scan was then registered to each other using Maptek’s PointStudio program and georeferenced to the Subtropolis Mine map. This allowed researchers to visualize the collapse area (Figure 9).

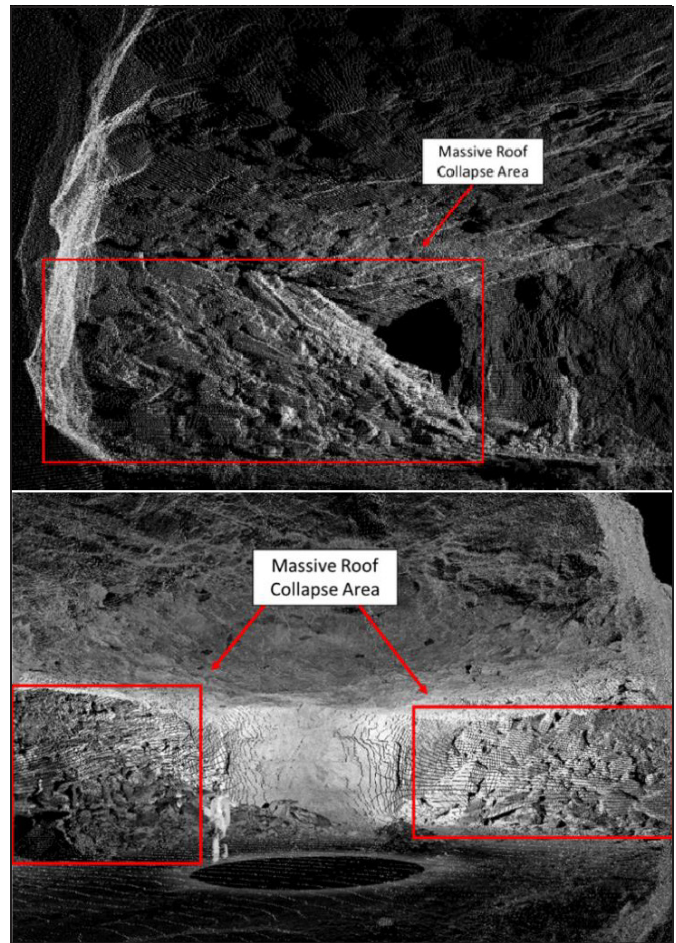
Figure 10 shows two images of the baseline pointclouds at a mine level view. Under a previous research project, the southern portion of the collapse area had been scanned prior to the majority of the failure. This acts as a very early baseline scan for that particular part of the collapse area. These baseline scans have been compared to other scans collected at later dates to look for the amount of change over time. Over the course of this study, changes have been seen in two portions of the collapse area. One area is the southern portion of entry N3N2, and the other is the northernmost portion of entry N3N7.

Figure 10. 3D LiDAR pointcloud images of the massive roof collapse at mine level

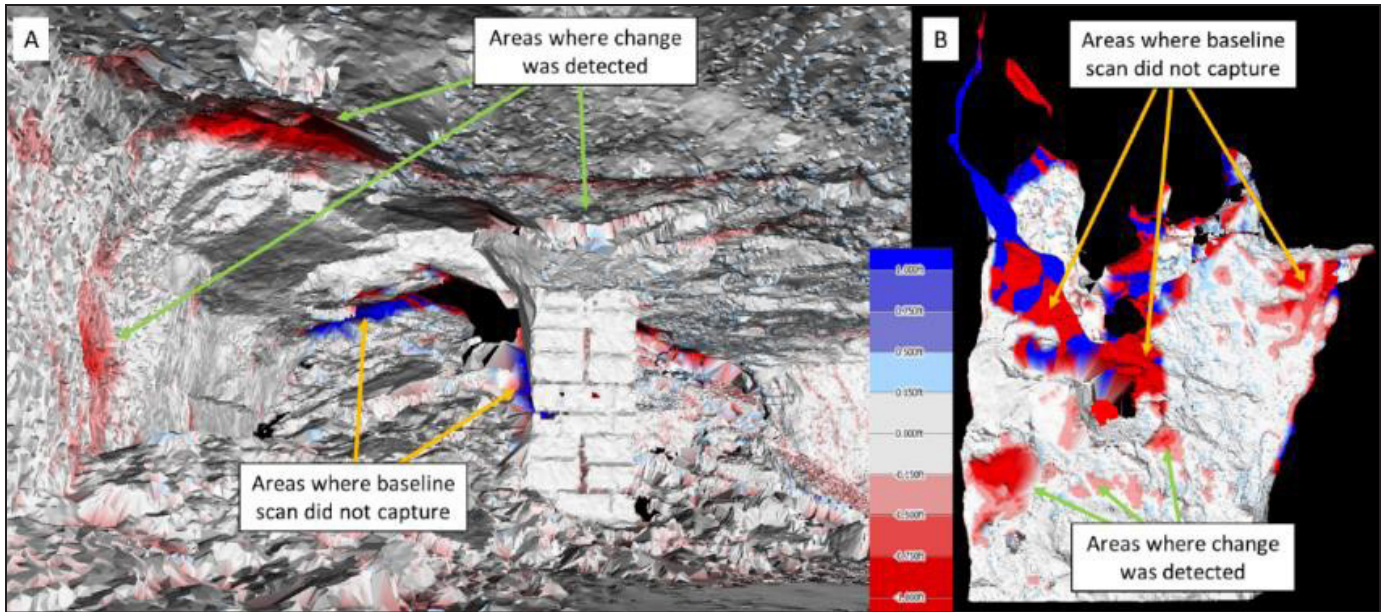
The northernmost portion of entry N3N7 as shown in Figure 11 saw changes to the rib and to the roof from July 2022 to October 2022. A separation of the lower layer of limestone in the roof occurred around a concrete crib. A large fracture opened up around the concrete crib and perpendicular to the entry. The southern portion of entry N3N2 saw significant changes to the west in the N3N1 entry, which was inaccessible to scanning in July 2022.

Figure 11. Changes over time in N3N7 from July 2022 to October 2022 (Red represents material removed and blue represents material added) A) In mine view B) Ariel view

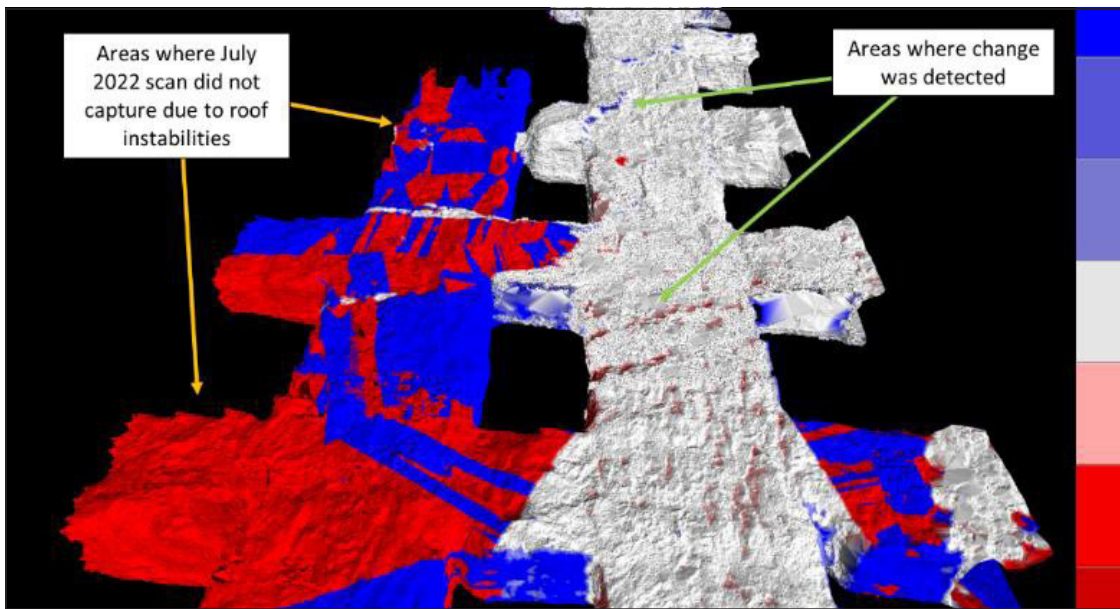
Therefore, July 2022 scans could be compared to June 2019 scans in entry N3N2. Changes were detected in the roof of N3N2 at an angle perpendicular to the principal horizontal stress direction as shown in Figure 12.

Figure 12. Ariel view of N3N2 changes over time from June 2019 to July 2022 (Red represents material removed and blue represents material added)

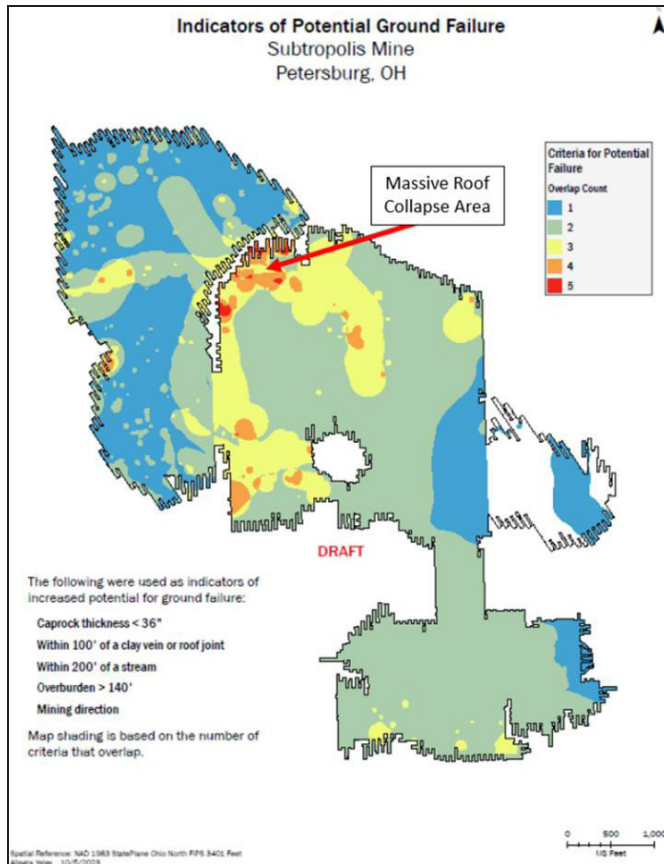
The AutoCAD version of the mine map that included the mine outline and the indicators listed above was imported into ArcGIS where a hazard map was produced (Figure 13). This map was produced without previous knowledge of the location of roof failure or the massive roof collapse. However, the map was able to indicate a potential for ground failure right over the massive roof collapse region. This may indicate that heading orientation,

Figure 13. Indicators of Potential Ground Failure Map of the Subtopolis Mine

overburden, stream beds, joints, clay veins, and caprock thickness might be leading factors in the cause of this massive roof collapse. The hazard map was also able to correctly map a hazardous area in the southwestern part of the mine, where a large roof fall occurred. This area had crisscrossing clay veins in the overlaying shale with several fractures in the roof and a constant flow of water prior to the fall. Cutter roof failures and rock flour were present during the failure as well indicating the shear failures as discussed in Figure 4. According to the operator, the Lower Kittanning Coal Seam may have also rolled down towards the top of the Vanport in this area.

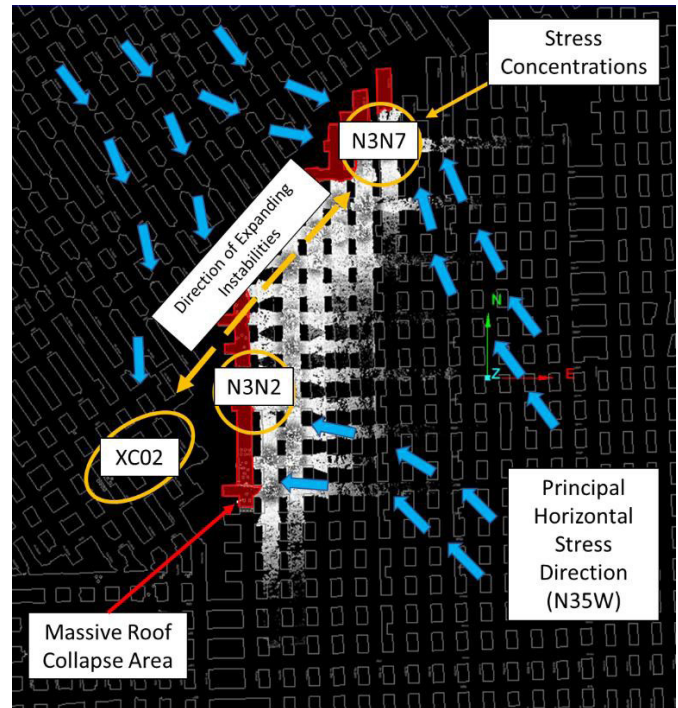
Figure 14. Ariel view of expected principal horizontal stress directional changes and concentrations around the massive roof collapse
