# A Case Study: Successfully Managing Excessive and Rapid Slope Deformation in an Open Pit Mine Utilizing Slope Monitoring Radar Systems

**Justine Ealy**

KGHM, Ruth, NV, USA

Knight Piésold Ltd., Vancouver, Canada

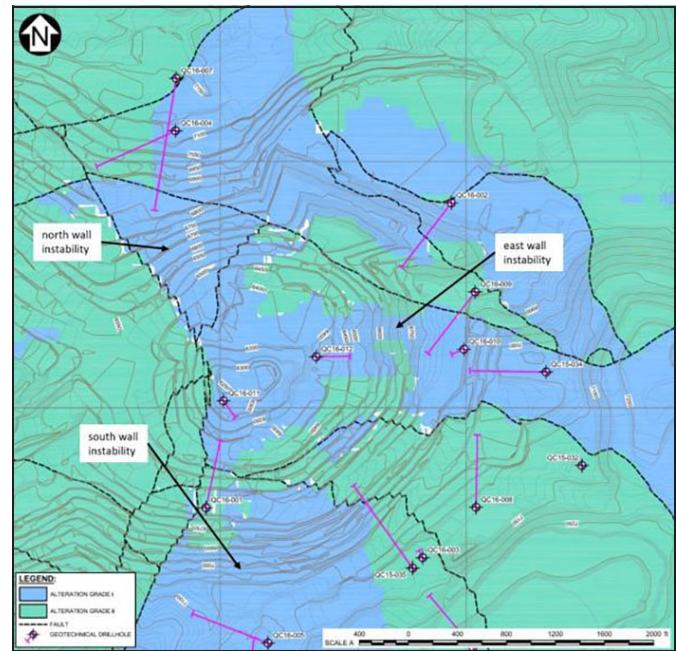
The rock mass domains of the pit are comprised of six main lithologies and two alteration grades. The six units include porphyry (intrusive), limestone, sandstone, shale, rhyolite (volcanic), and fault zones. Significant degradation of the rock mass quality and strength are attributed to phyllic, argillic, potassic, propylitic, and gossan alteration or Grade (i), with examples shown in Figure 1. The second alteration Grade (ii) has little adverse impact on the rock mass quality or strength and represents unaltered rock. Figure 2 illustrates the alteration grades and known faults in the 2016 open pit (Yong, et al 2022).

**Figure 2. Map of the entire pit indicating the two different alteration grades (Yong, et al, 2022).**

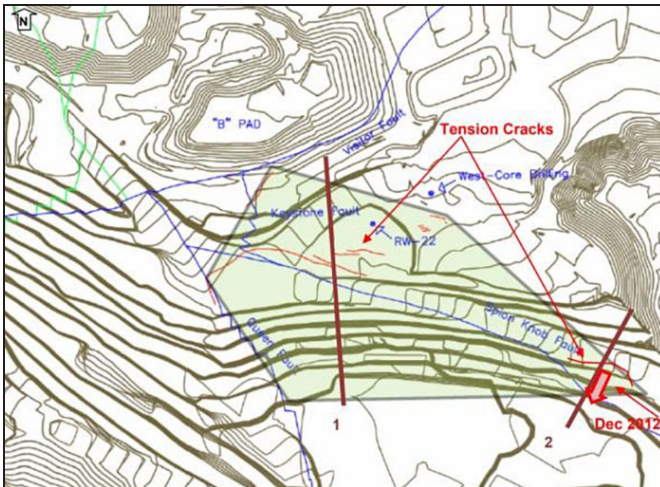
By late 2012, tension cracks were observed in a haul road located directly above the north wall. A dewatering well also had to be abandoned in the area due to the ongoing slope deformation. Slope monitoring radar registered that the northern wall had an average velocity of about 2 inches per day.

**Figure 3. Topographic map of the 2012 northern wall, with indications where tension cracks were observed (Yang, 2013).**

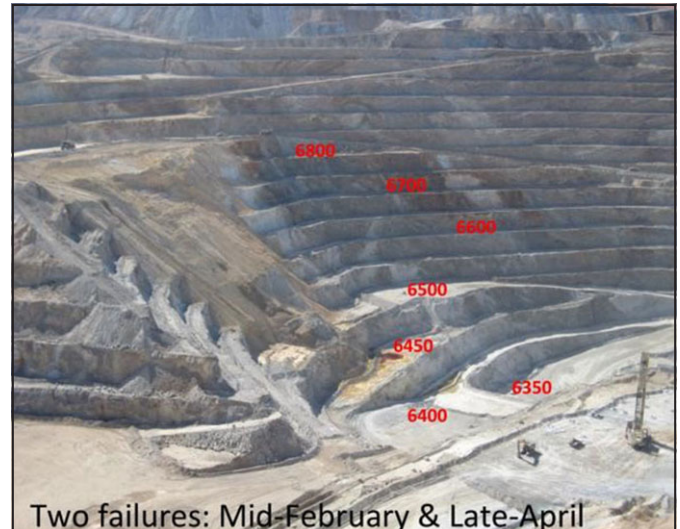
In February 2015, a slope movement occurred on the eastern wall of the pit due to high pore water pressures, saturated toe, and very weak rock masses. The mine initially mitigated the area by dozing down the loose material, but the mass had eventually shifted again by April of the same year.

**Figure 4. Photograph showing the high-wall movement on the eastern side of the pit (Yang, 2015).**

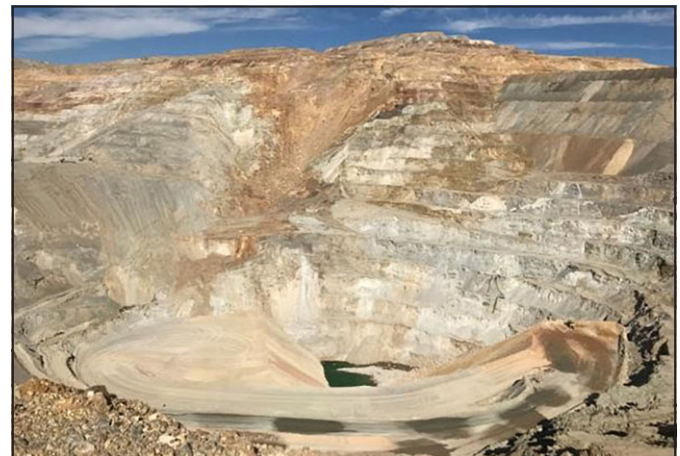
**Figure 5. Photograph of the northern wall taken in 2020. Backfilling operations were started to buttress against further movement.**
