# A Surface Geotechnical In-Pit Underground Portal Relocation: An Operations-Based Case Study

**Russell J. Sheets**

Barr Engineering Co., Bismarck, ND, USA

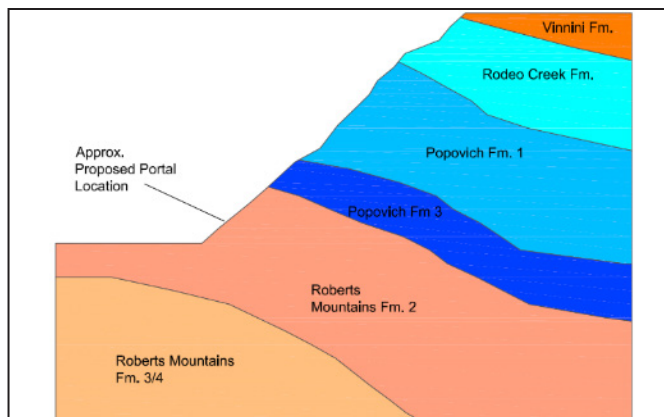
Based on the current surface geology model and mapping information, this area of highwall is primarily composed of: Rodeo Creek Formation, Popovich Formation, and Roberts Mountains Formation. The bedding and formation contacts tend to dip toward the northeast around as observed from exposed pit slopes. Since, the proposed portal location would be located in an area of highwall that trends northwest to southeast, the formation contacts are dipping back into the highwall. Typically, this combination of pit slope and structural intersections lead to a more stable configuration (see Figures 2).

**Figure 2. Geologic cross-section through the proposed portal location. There were no major faults according to the geology model; geologic formation contacts are dipping away from the pit toward the northeast.**

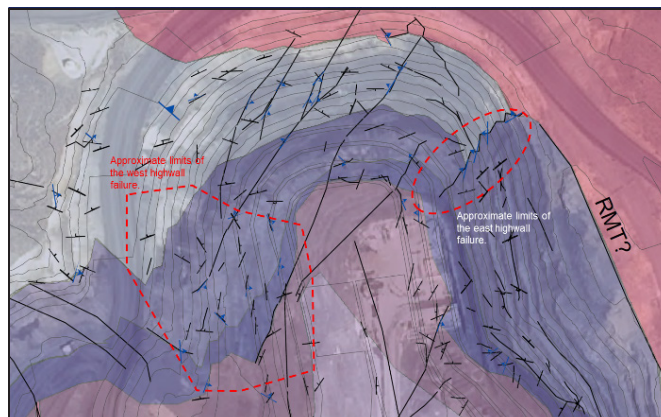
Fortunately, these conditions are different from the geologic conditions that were observed in the north end of the open pit and associated with bounding the ongoing slope failures. The west wall failure had been developing along fault and formation contacts. The contacts between the Rodeo Creek, Popovich, Roberts Mountains Formations are in proximity, with an overall pitward dipping orientation with respect to the highwall. Infiltration from precipitation and surface run-off over time, accelerated deterioration along structures and contacts. The weakening resulted in the instability that began to develop in December 2015. This area is shown in Figure 3.

Similarly, the local failure above the existing portals was occurring along a modeled fault structure that is also the contact between the Rodeo Creek and Popovich Formations. The projection of the fault/contact in the highwall was near vertical above the northern portal. Failure along this structure did begin during surface mining activity of the final phase. Over the past several years, the existing failure and weak material along the contact has continued to deteriorate; particularly when there have been winters or springs with above average precipitation. The area is indicated in Figure 3.

**Figure 3. Geologic map of the northern end of the open pit. The observed slope failures were controlled by both geologic formation contacts and known faults.**

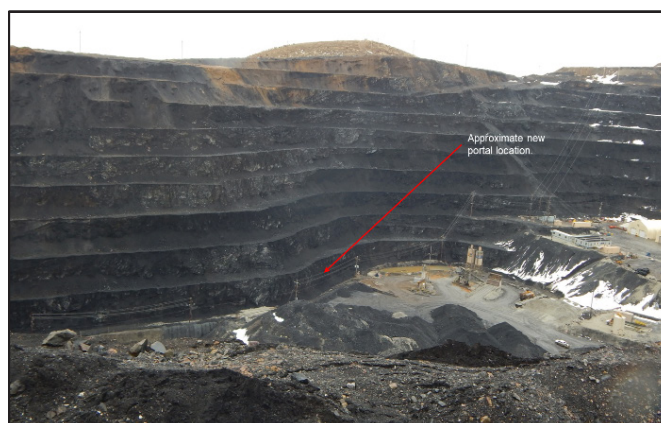
**Figure 4. View of the highwall above the proposed portal location. The catch benches contain material along each bench toe; however, there are no signs of slope movement.**

instabilities had or were developing. Pictures are included as Figures 4, 5, and 6. The upper two benches do exhibit more substantial deterioration and weathering (Figure 4). This was observed in the Vinnini and Rodeo Creek Formations as surface mining was developing each phase of the open pit. There were some localized failures that were the result of weak material not able to remain stable when excavated at 65-degree bench face angles; however, these had been contained on the existing catch benches.

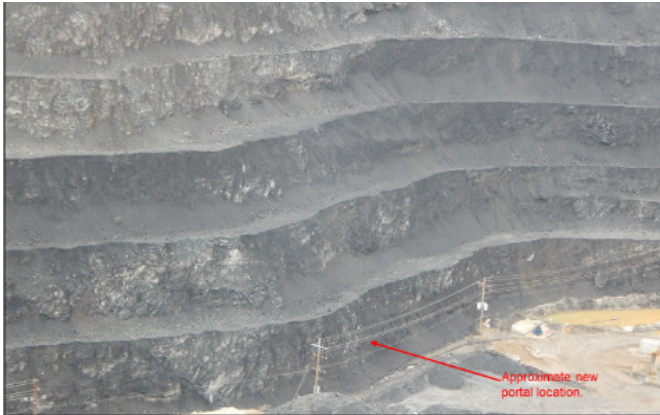
**Figure 5.** A closer view of the highwall above the proposed portal location

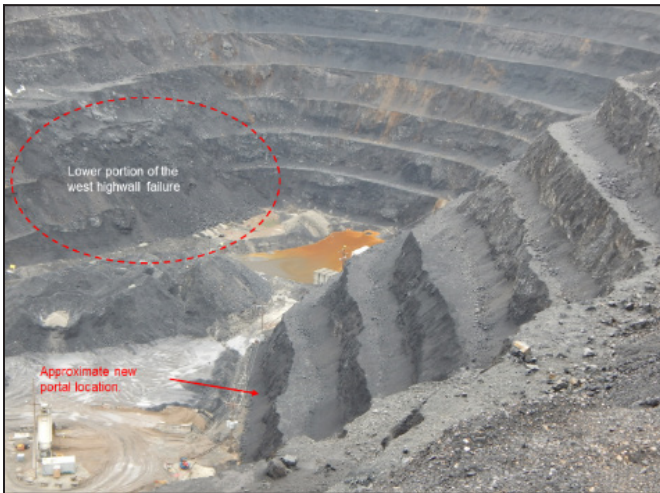
**Figure 6.** A view looking parallel to the highwall and catch benches above the proposed portal location

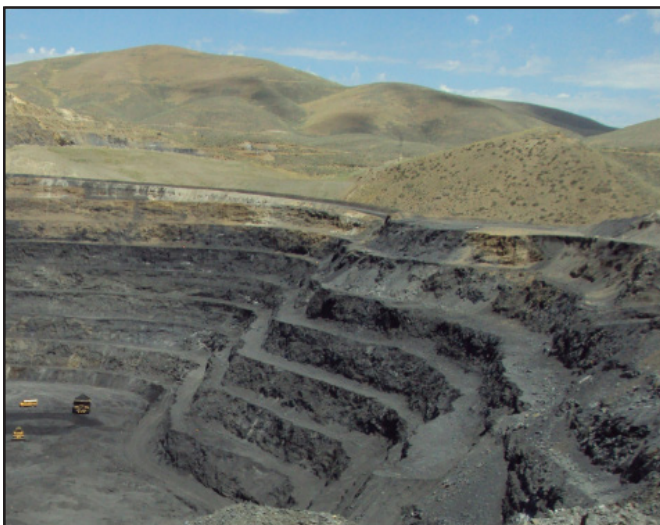
The remainder of the of the open pit slopes had performed very well, considering the local geological and geotechnical conditions exposed in the instabilities. There is, of course, minor ravel and sloughed material that had accumulated at the toe of each bench face; however, when examining photographs of the same area taken in July 2010 (see Figure 7) and January 2011 (see Figure 8); it does appear that most of the material accumulated either during

**Figure 7.** A July 2010, photograph that shows the upper benches of the highwall above the proposed portal location

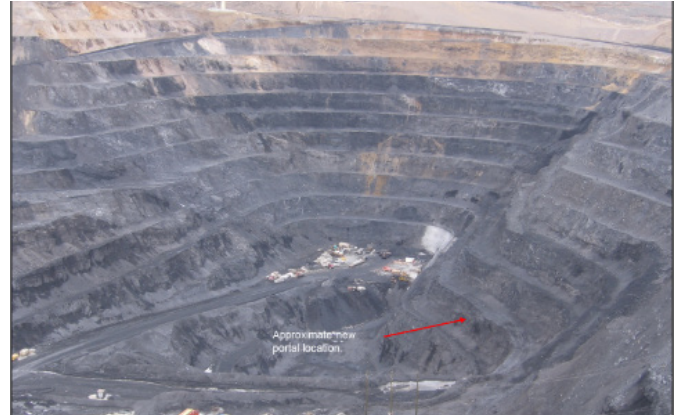
**Figure 8.** This January 2011 photograph shows the highwall above the proposed portal location. Development of the existing portals has commenced in the northern end of the pit.

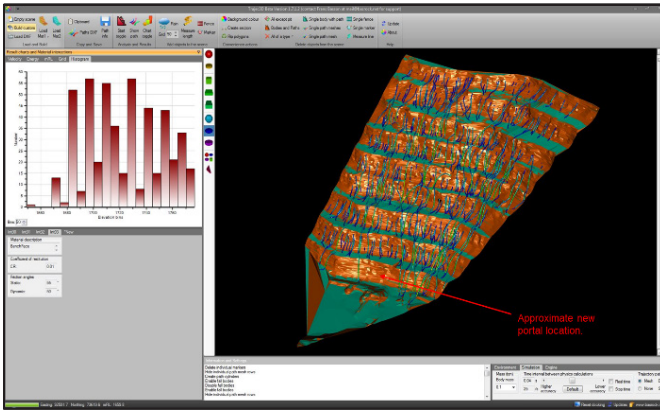
**Figure 9. Three dimensional rockfall analysis conducted on the existing highwall geometry**

Two model scenarios were evaluated. The first evaluated the condition of the open pit slope in its current condition at the time of the assessment; these results are depicted in Figure 9. The second analysis was conducted with a 3-ft barrier (berm or fence) along the crest of the catch bench immediately above the proposed portal. This allowed a comparison of the estimated rockfall events that could be retained above the portal and surrounding area, which is shown in Figure 10, with the results of the current condition analysis.

- A total of 14 rockfall events could reach the floor/toe of the open pit slope ( $14/500 \times 100\% = 2.8\%$ ) for the existing conditions.
  - Most of these events occurred at the southern extend of the proposed portal area, where back break during active surface mining reduced the catch bench width and allowable containment.

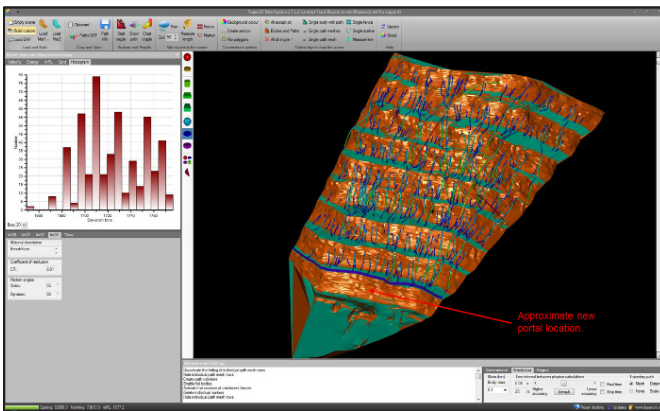
**Figure 10. Three dimensional rockfall analysis conducted on the current highwall geometry with a 3-ft barrier along the crest**

- A small barrier (i.e., berm) constructed along the bench above the portal mitigated all modeled rockfall events from reaching the floor/toe of the highwall.
