# Principal Horizontal Stress Contributing to Massive Roof Collapse at the Subtropolis Mine

NIOSH, Pittsburgh PA

## ABSTRACT

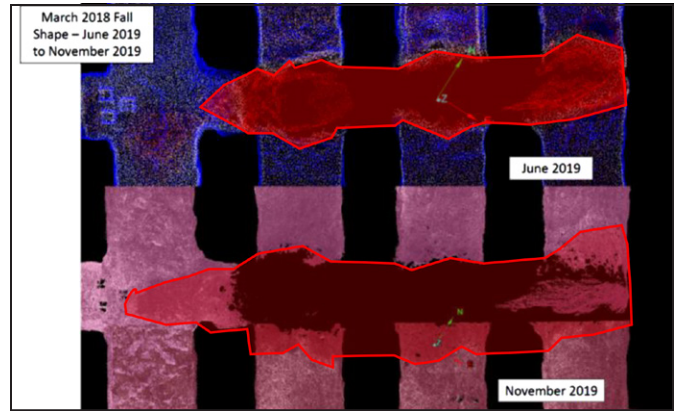
**Figure 5. March 2018 roof fall in XC02 progression from June 2019 to November 2019**

Figure 5 shows 3D LiDAR scans capturing the shape of this type of fall and its growth over time (shown in red). In this fall, the failure extends approximately 30 ft into the roof and up into the overlying coal seam. The shear failure orientations are parallel to the long axis of the elliptical-shaped cavities in this case study. All of these damages have been captured using detailed geologic mapping and, in some cases, 3D LiDAR scanning. For example, Figure 6 contains two photos from the Subtropolis Mine. Photo A is an example of a dilating beam and Photo B shows shear failure in three separate fully-grouted bolts from the same area.

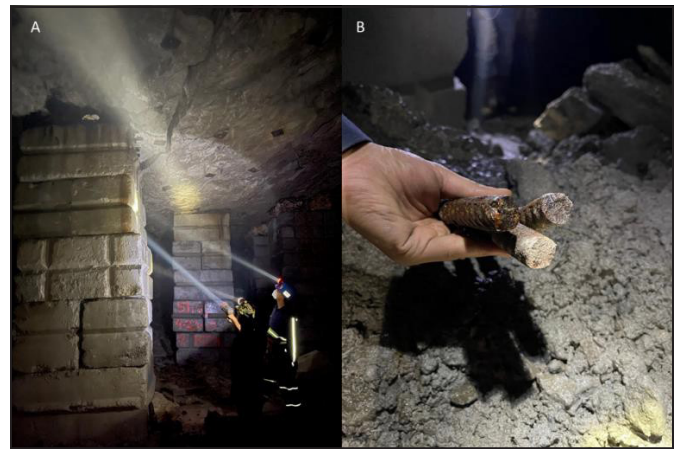
**Figure 6. A) Photo of shear failure in roof and B) Photo of sheared bolts**

Failures appear to originate in the lowest beams, or the beams closest to the mine opening due to the concentration of stresses in the lower beam and constraints to bending in the upper beams (Iannacchione et al., 1998). Therefore, failure begins with a shear in the first foot of the caprock. Shear failures appear as low- angle ruptures in the rock with a kind of “rock flour” along the newly created surface (Iannacchione et al., 2019). Then, the shear propagates, and the beam begins to dilate. Next, the beam begins to cantilever, causing tensile failure along the boundary between the roof and the pillar. Once the beam fails completely, the shear failure propagates to the next layer. In other mines the shear failure continues to propagate upwards through the roof layers until the fall has developed an arch shape. However, at the Subtropolis Mine there are very weak shales present above the caprock. Here, once the caprock fails, the fall takes on a chimney shape and, in some cases, extends approximately 30 ft into the roof.

The operator noticed that these types of failures in the N-S entries appear to concentrate at the northwest and southeast corners of the pillars. In order to minimize the number of these types of roof failures, the mine utilized the stress control layout. The stress control layout utilizes headings in the principal horizontal stress direction. This minimizes damage to the headings but concentrates damage into the crosscuts. To minimize damage to the crosscuts, the mine has implemented the use of rectangular pillars. The mine also has implemented a secondary bolting strategy and included windows in every other crosscut. According to Evanek et al. (2020), “Windows are used to resist horizontal movements or deformation that occur parallel to the maximum horizontal stress direction or perpendicular to the direction of stress failures. A window is developed by leaving an increased thickness of roof rock in the crosscuts, thus reducing the crosscut dimensions

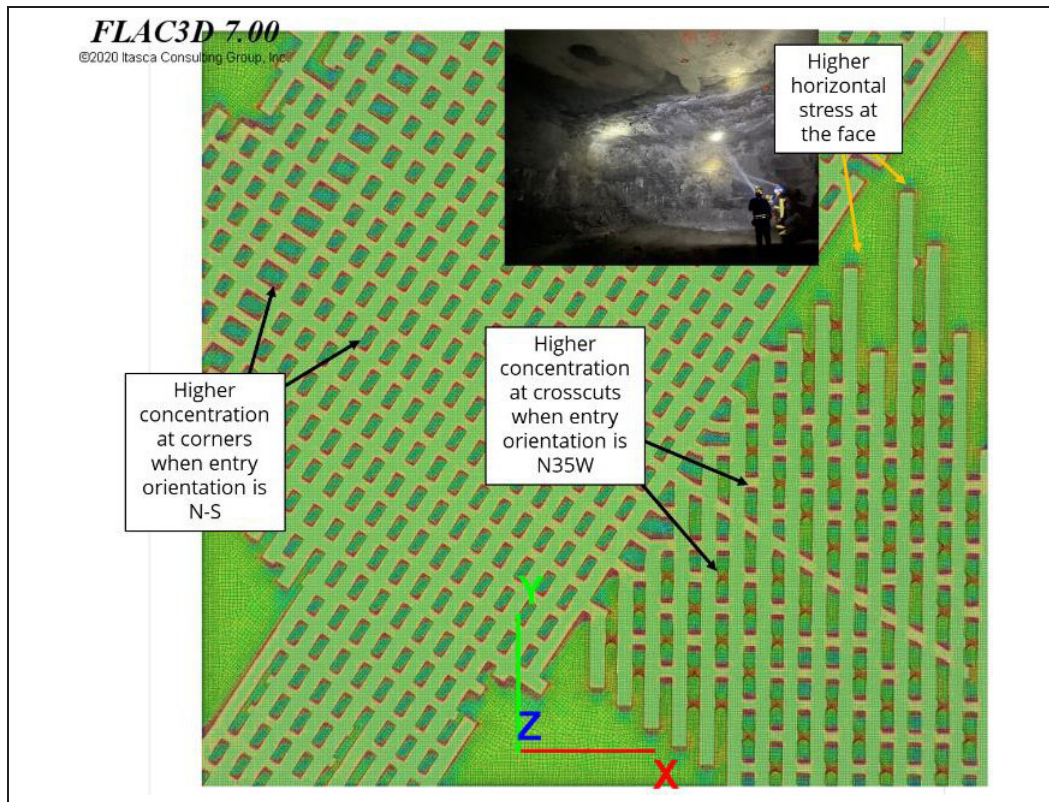
Figure 7. Model of distribution of maximum principal horizontal stress

vertically.” The first time the stress control layout was implemented at the mine was in the northwestern region of the mine in 2018, on the other side of the massive collapse area. Numerical modeling was utilized in this study to confirm damage patterns seen at the mine. The model, as seen in Figure 7, maps the distribution of the maximum principal horizontal stress over two different mine layouts at Subtropolis. The principal horizontal stress in this model is parallel to the Y-axis in the figure at N35W. The pillars with a N-S orientation show a higher concentration at the corners of the entry (indicated by red), which aligns with damages mapped underground. The pillars oriented parallel to the principal horizontal stress at N35W show damage (indicated by red) being concentrated at the crosscuts and not in the entries. This damage concentration has also been mapped at Subtropolis and also confirms the stress control layout is working as planned.

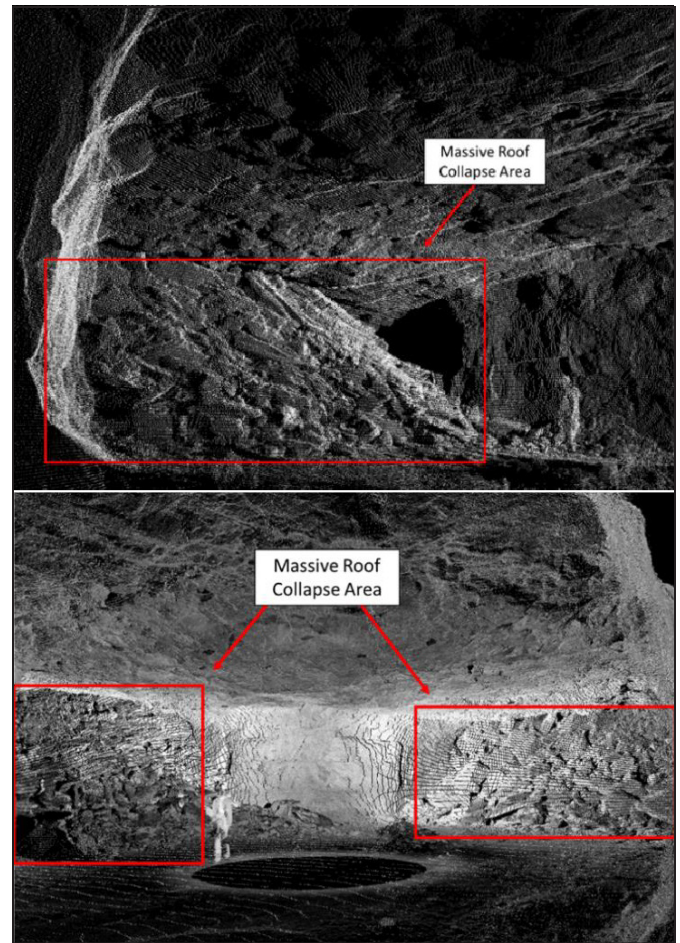
**Figure 10. 3D LiDAR pointcloud images of the massive roof collapse at mine level**

Figure 10 shows two images of the baseline pointclouds at a mine level view. Under a previous research project, the southern portion of the collapse area had been scanned prior to the majority of the failure. This acts as a very early baseline scan for that particular part of the collapse area. These baseline scans have been compared to other scans collected at later dates to look for the amount of change over time. Over the course of this study, changes have been seen in two portions of the collapse area. One area is the southern portion of entry N3N2, and the other is the northernmost portion of entry N3N7.

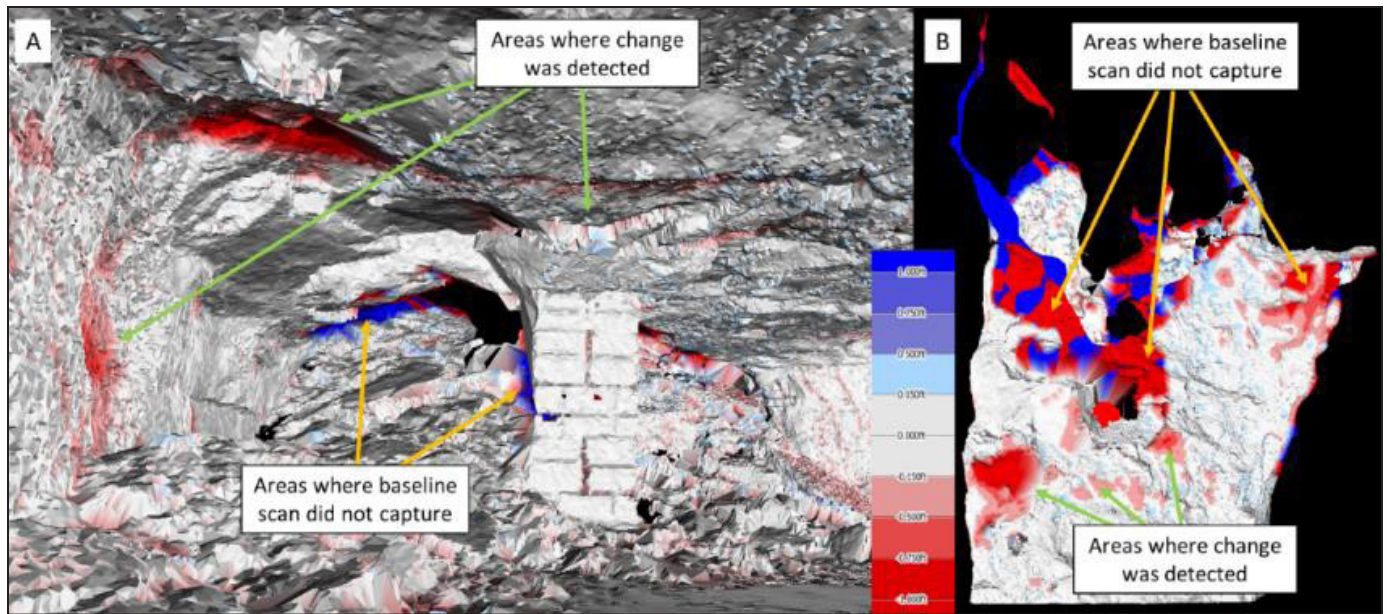
Figure 11. Changes over time in N3N7 from July 2022 to October 2022 (Red represents material removed and blue represents material added) A) In mine view B) Ariel view

The northernmost portion of entry N3N7 as shown in Figure 11 saw changes to the rib and to the roof from July 2022 to October 2022. A separation of the lower layer of limestone in the roof occurred around a concrete crib. A large fracture opened up around the concrete crib and perpendicular to the entry. The southern portion of entry N3N2 saw significant changes to the west in the N3N1 entry, which was inaccessible to scanning in July 2022.

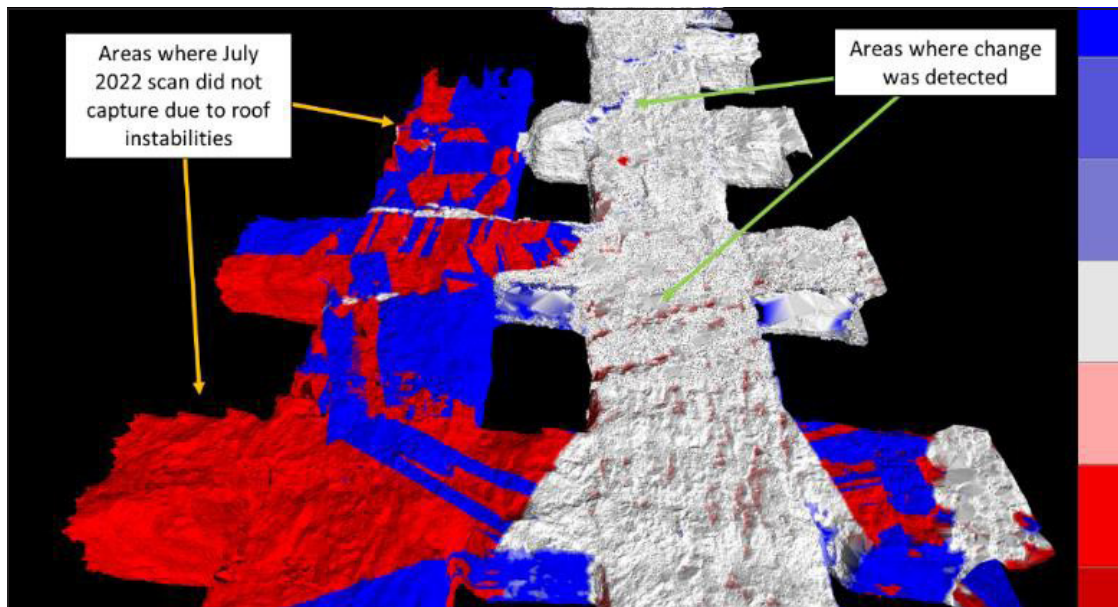
Figure 12. Ariel view of N3N2 changes over time from June 2019 to July 2022 (Red represents material removed and blue represents material added)

Therefore, July 2022 scans could be compared to June 2019 scans in entry N3N2. Changes were detected in the roof of N3N2 at an angle perpendicular to the principal horizontal stress direction as shown in Figure 12.

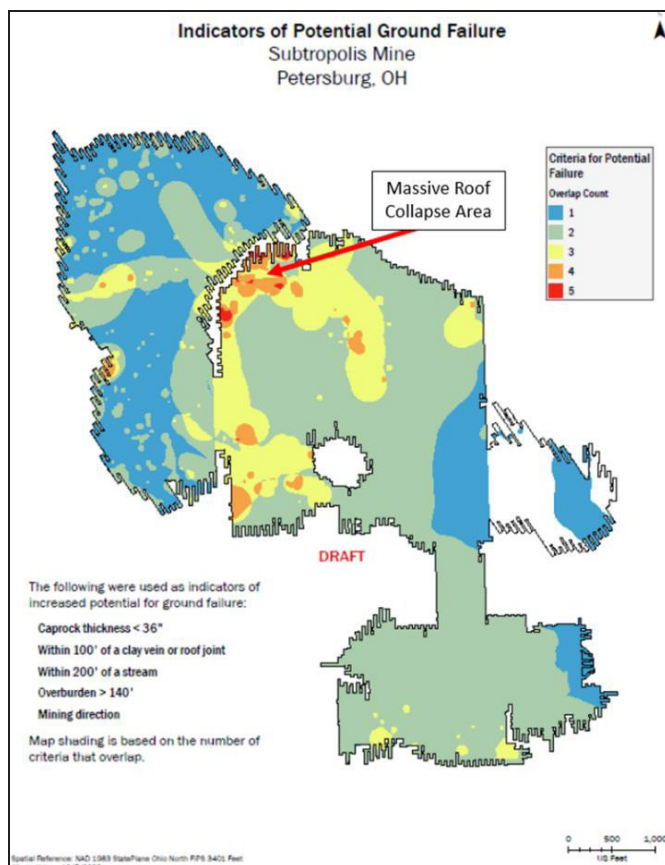
**Figure 13. Indicators of Potential Ground Failure Map of the Subtopolis Mine**

The AutoCAD version of the mine map that included the mine outline and the indicators listed above was imported into ArcGIS where a hazard map was produced (Figure 13). This map was produced without previous knowledge of the location of roof failure or the massive roof collapse. However, the map was able to indicate a potential for ground failure right over the massive roof collapse region. This may indicate that heading orientation,

overburden, stream beds, joints, clay veins, and caprock thickness might be leading factors in the cause of this massive roof collapse. The hazard map was also able to correctly map a hazardous area in the southwestern part of the mine, where a large roof fall occurred. This area had crisscrossing clay veins in the overlaying shale with several fractures in the roof and a constant flow of water prior to the fall. Cutter roof failures and rock flour were present during the failure as well indicating the shear failures as discussed in Figure 4. According to the operator, the Lower Kittanning Coal Seam may have also rolled down towards the top of the Vanport in this area.

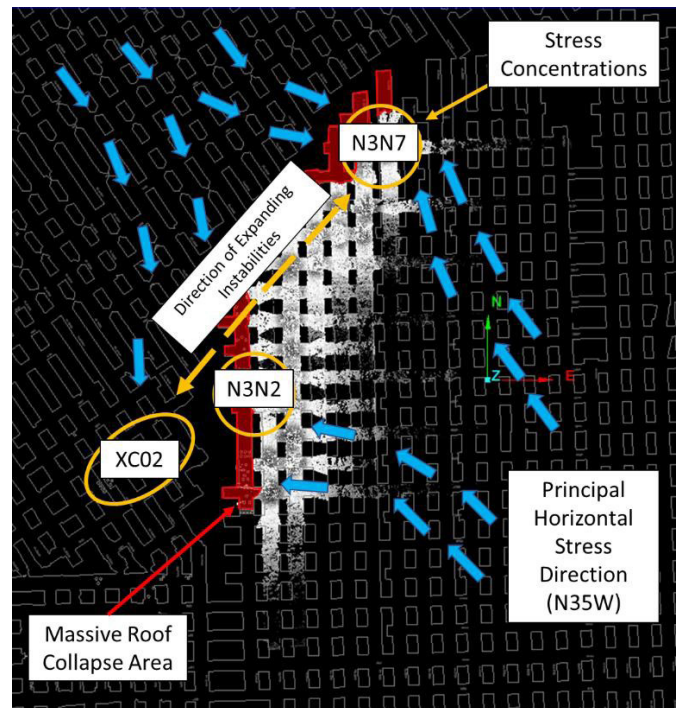
**Figure 14. Ariel view of expected principal horizontal stress directional changes and concentrations around the massive roof collapse**

The massive roof collapse at Subtopolis Mine is still expanding slowly over time. Geologic mapping and 3D LiDAR scanning showed that instabilities are expanding relatively quickly perpendicular to the principal horizontal stress direction and expanding relatively slowly parallel to the principal horizontal stress direction (Figure 14). Strata failures around the margins of the collapse area can reinitiate depending on the proximity of the mining front.
