# Corrosion Strategies at the Resolution Copper Project, Arizona

Resolution Copper

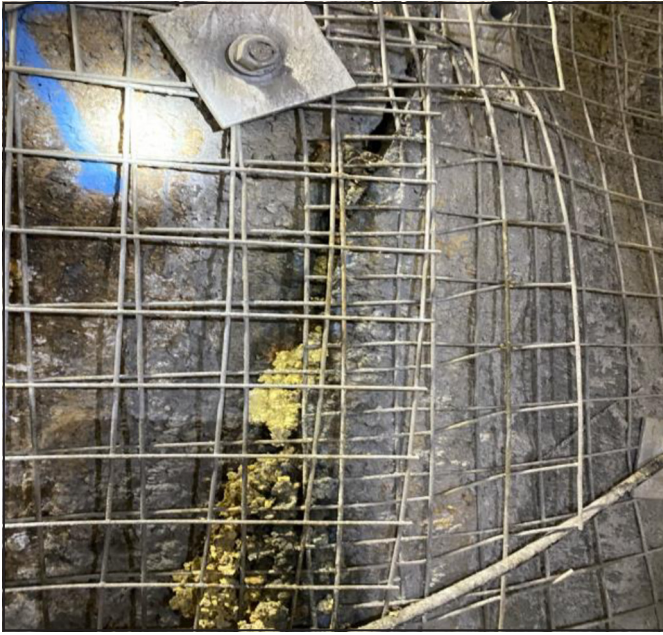
**Figure 4: Examples of corrosion precipitates in cracks through shotcrete**

Figures 4–6 show low pH paste and efflorescent salts effection bolt corrosion.

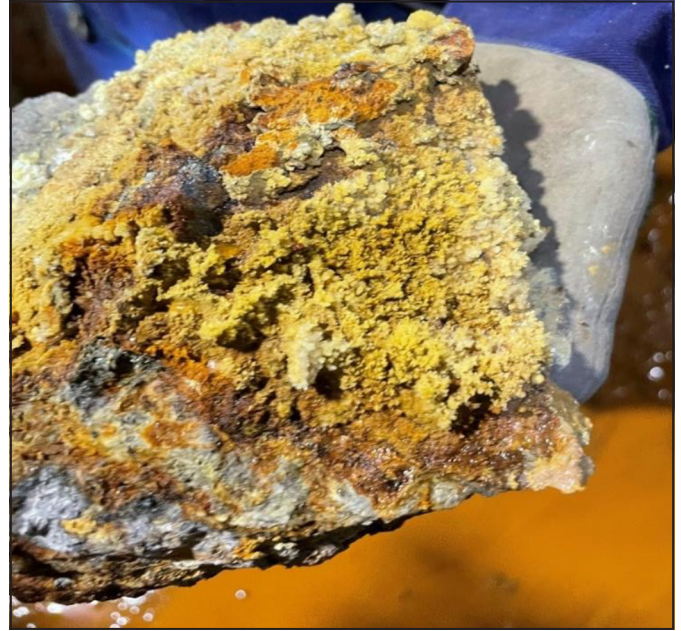
**Figure 5: Examples of corrosion precipitates from TPL2(68L) indicates hydroxysulfates such as jarosite [ $\text{KFe}(\text{SO})(\text{OH})$ ]. From Logston, 2022**

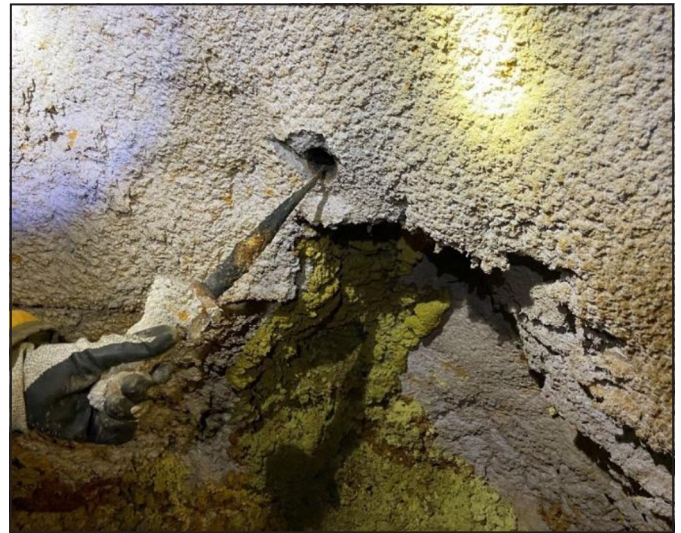
**Figure 6; Corroded rock bolt extracted from 68 Level . Note corrosion although portion of the bolt was surrounded by shotcrete. Yellow (white to greenish) efflorescent minerals are recent/current precipitates**

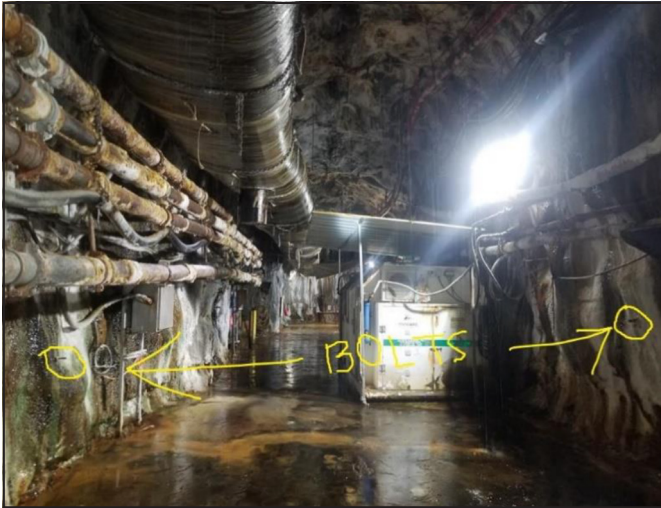
Figure 7. TPL2 or 68 level pump station area of bolt testing and overcoring in 2015

Results from TPL2(68 level) Pumping Station were published September 2019(CTL, 2019). Four eight-foot resin bolts installed between March and May 2015 were overcored and tested (see Figure 7). The primary finding was that corrosion was due to anions: heavy local corrosion at the anchor head. Worst case bolt life of about 7 years to maintain at least 15 tons capacity. Of the 4 reinforced rebar bolts tested, low pH was the primary corrosion element.

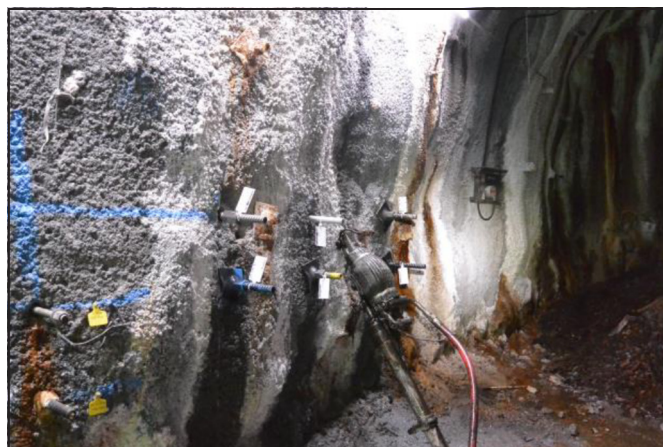
Figure 15. Various type bolts and coatings for future corrosion overcoring and testing, Old Electrical Room, 68L

Our current action plan to over the past year has been to try out several different bolts in highly corrosive areas for pull testing and overcoring to test for encapsulation voids and for degree of corrosion over time (see Figures 15 and Figure 16). The results for corrosion over 5 years will give us more accurate data, as we are testing various type bolts with various corrosion resistant coatings like epoxy and thermoplastic.
