Corrosion Strategies at the Resolution Copper Project, Arizona

Louis Sandbak
Resolution Copper

Gabino Preciado
Resolution Copper

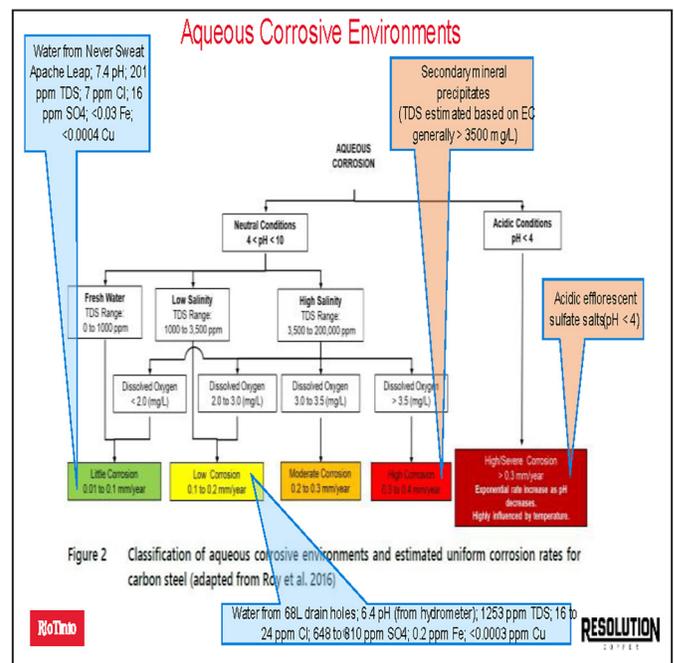
Figure 1 shows the two characteristics of the water from the Never Sweat Tunnel, TPL2 boreholes, and the areas of highly corrosive and low ph efflorescent salts for portions of the 68L. The water from the NST and from the 68L boreholes waters show low to moderate dissolved solids(salinity), and, therefore low corrosion potential. The Hatch report (2018) from the 68 Level or TPL2 has shown moderate dissolved solids ranging from 1,100–1,400nmg/L the tendency to form Calcium Carbonate scale, and a high tendency for steel corrosion.

Figure 1. Water samples, and corrosive environments based on observations at RC. Information plotted on Aqueous classification chart. From Logsdon, 2022

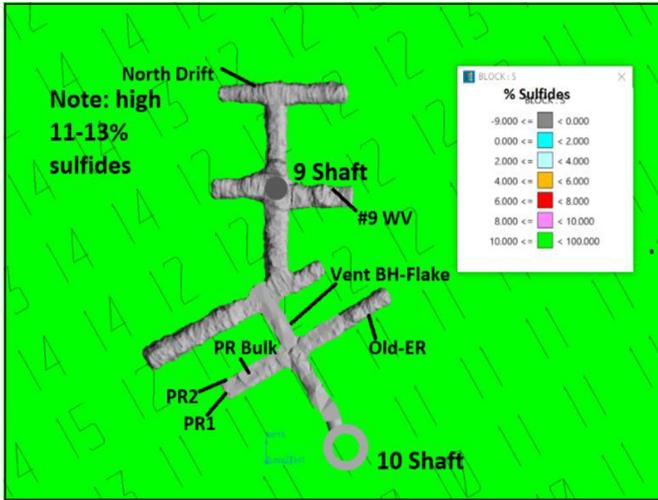
Figure 2 is a plan map of the 68-level showing where the samples were taken, with an overlay of the percent total Sulphur from the geologic block model. It shows a *bimodal* distribution of extremely highly acidic in the PR bulk, PR2 and North Drift, and primarily neutral to alkalic in the remainder of the drifts. Based on descriptions and pictures of the underground conditions, considers that the alkaline conditions that exist are associated with exposures of shotcrete, whereas the acidic locations are influenced by the oxidizing pyrite that is not protected by shotcrete. The higher

Figure 2. Plan map of TPL2(68 level) showing total percent sulfur from geology block model

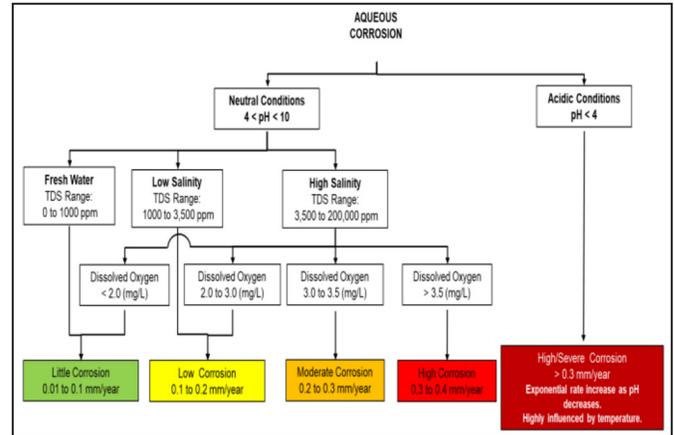
Figure 3. Classification of aqueous corrosion and estimated corrosion rates for salinities, dissolved oxygen, or total dissolved solids. From Preston and others, 2019

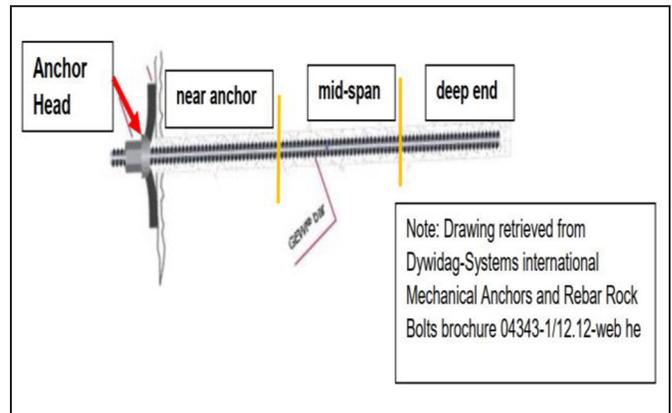
- Corrosive attack occurred on all extracted bolts in varying degrees along the length, but degree decreases with depth along the bolt. Heavy pitting attack and general attack was present in *first third of each bolt* (closest to tunnel, ear anchor). Pitting attack and general corrosion were present mid-span on each extracted bolt. General corrosion was present on the inner-most embedded section (the deep end) of each extracted bolt.

Figure 10. Corrosion loss for rebar bolts, and photos sample 36195 showing near anchor, mid-anchor and deep end corrosion from (CTL, 2019) bolt tests

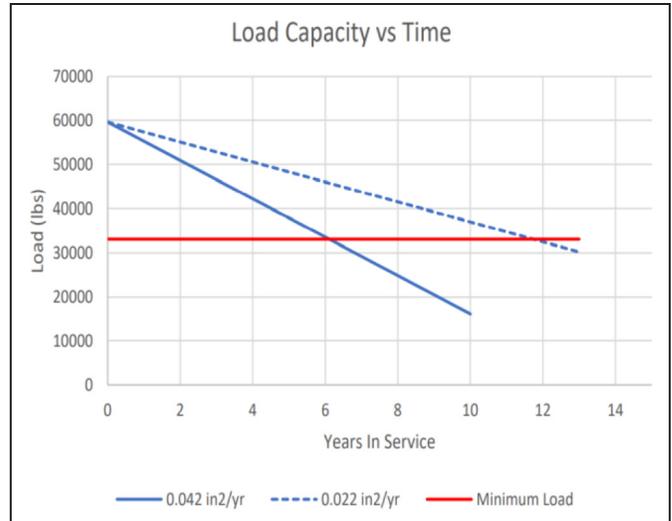
Figure 11. Graphical plot of load capacity vs time for 2 resin rebar bolts in 68L Pump Room based upon calculated corrosion rates (from PNL, 2023)

The conclusions were that the two bolts were either not fully encapsulated or properly installed initially in October 2020. It also brings up the difficulty in installation of bolts with the current cartridge package resin systems and jacklegs. The presence of large amounts of hot water in weaker ground may also affect resin-bondage when mixing. The greatest loss in cross-sectional area was found in the #2 bolt (0.50 in^2) and yields a corrosion rate of 0.042 in^2/yr. The average cross-sectional loss of 0.54 in^2 (which was consistent on both bolts samples examined) yields a corrosion

rate of 0.022 in 2/yr (see Figure 11). Based upon these values, the bolts are estimated to fall below the minimum pull strength at approximately 6 years for minimum and 12 years for average corrosion.

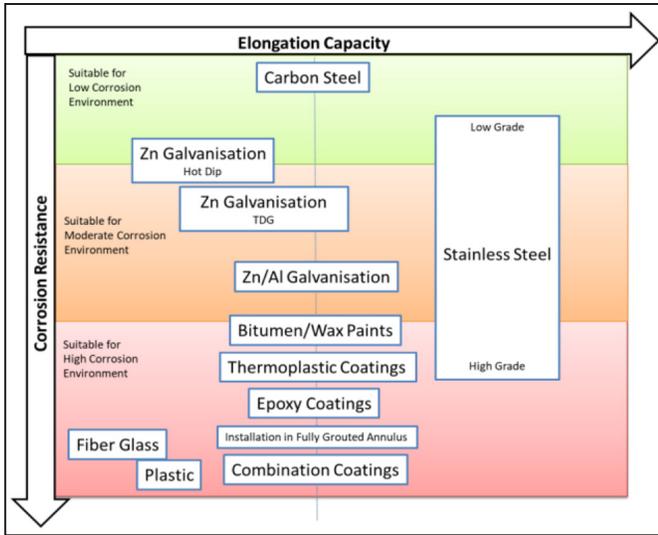
Figure 12 is a diagram from Preston and others (2019) that shows the relative corrosion resistance versus elongation capacity. It emphasizes the use of grouted or resin fully encapsulated bars as providing the most resistive to corrosion. The grout or resin provides a barrier between the steel and the mine water. Encapsulation using grout is shown as

Figure 12. Relative corrosion resistance versus elongation capacity for corrosion protection measures. From Preston and others, (2019). Note: Installation in fully grouted anulus offers best corrosion protection next to any additional combinational coatings

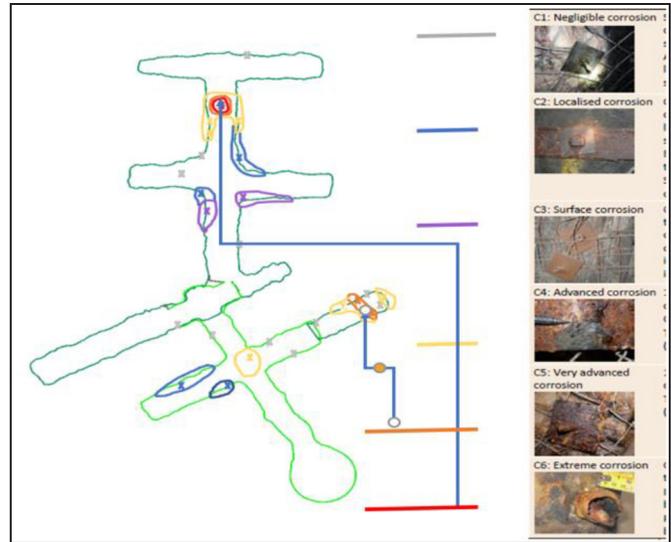
Figure 13 is a plan map of the 68 L showing the corrosion damage extents using Corrosion level classification system. Because of the recent bolt failures, and past testing showing inadequate encapsulation near the collar, any temporary rehab bolting, especially with jacklegs will eliminate using resin cartridges, and use pumpable resin. For permanent long-range support, a resin injection system is to be used to insure full encapsulation for weak and highly veined rock with high moisture content.

Figure 13. Corrosion Plan Map of TPL2(68L) based on Hadjigeorgiou and Dorian, 2013 corrosion classifications

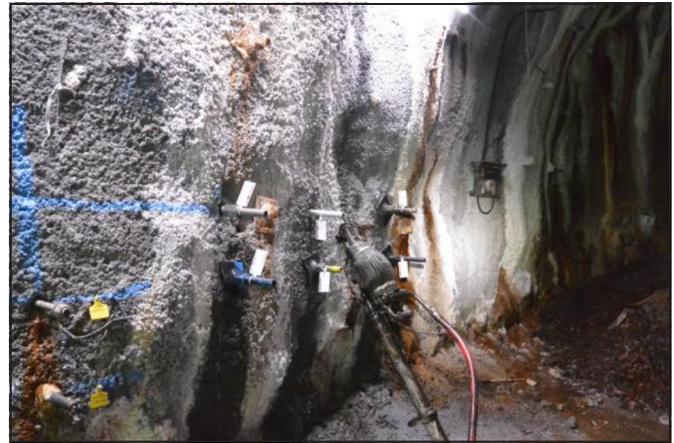
**Figure 16. Pumping 2-part resin for test bolts in Old Electrical room, 68L**
