# Principal Horizontal Stress Contributing to Massive Roof Collapse at the Subtropolis Mine

NIOSH, Pittsburgh PA

## ABSTRACT

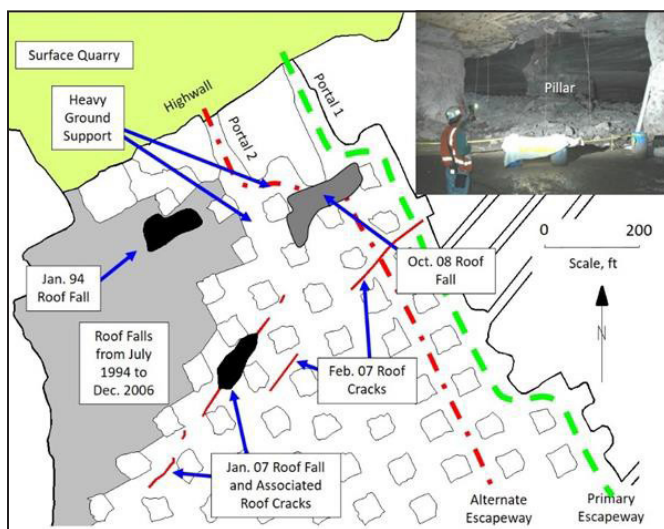
Safety and Health (NIOSH) Lake Lynn Research Facility which occurred slowly from 1994 to 2006 (Figure 1). The cause of the Lake Lynn massive roof collapse has been studied and several factors are suggested including weathered joints, inadequate caprock thickness, exceedingly weak strata above the caprock, strata dips that favor strata extension into the adjacent surface quarry, freeze-thaw action in the entries near the highwall, and a lack of adequate support.

**Figure 1. Location and dates of massive roof collapse at the Lake Lynn Laboratory from 1994 to 2007**

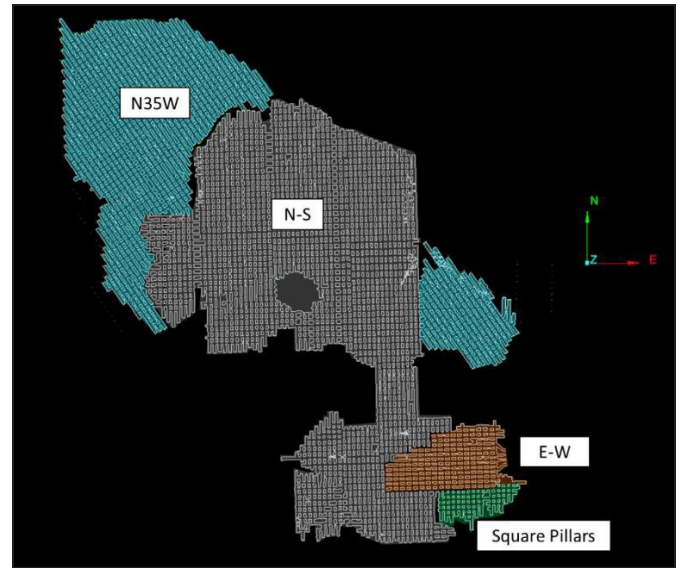
Typically, a mine will find the orientation of the principal horizontal stress at or near to the regional horizontal stress. At the Subtropolis Mine, the principal horizontal stress differs from the regional horizontal stress and can even differ across the mine itself. Evidence to support these changes in the principal horizontal stress direction come in the form of cutter roof failures and oval-shaped roof falls oriented in different directions in specific areas of the mine. The principal horizontal stress direction at this mine tends to be generally N35W.

**Figure 3. Subtropolis Mine Map with varying heading orientations**

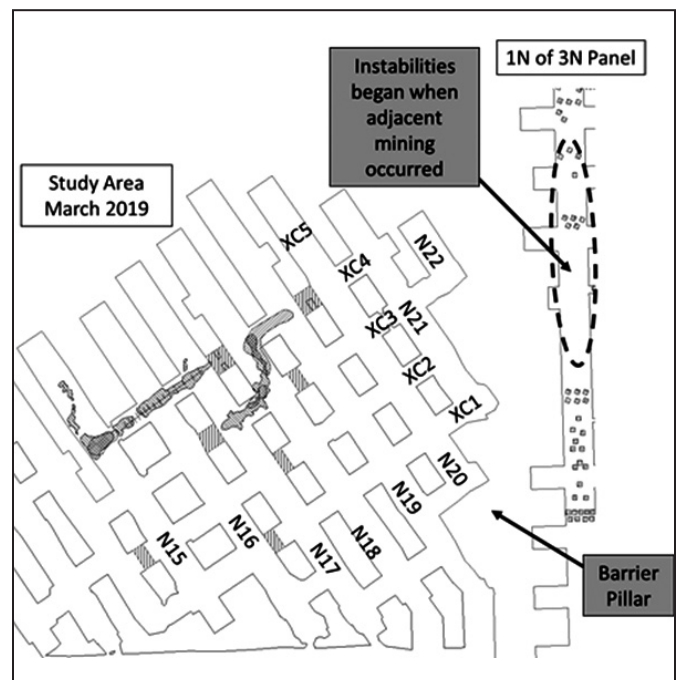
In 2015, a massive roof collapse at Subtropolis Mine began to form in the northwestern portion of the mine. From April of 2016 to the end of 2018, the collapse area had been relatively quiet. However, in 2019, mining began to extend close to the old workings where the collapse had occurred. Instabilities began to form again, and the size of the collapse began to grow. In addition to its growth in the old workings, new damages began to “jump” into the new workings, causing a major roof fall in one of the crosscuts nearest to the old workings and with the lowest caprock thickness (Figure 8). Since mining moved further from the edge of the collapse area, damages were expected to stop. However, due to the presence of horizontal stress at this mine, the collapse has not stopped progressing further into the roof and outward into the open entries. The operator had witnessed the role horizontal stress played in the collapse. Damages progressed slowly as cutters began to run from east to west from the collapse area and the operator was able to follow the shifting of the test holes as it went. 3D LiDAR scanning was able to capture some of these changes over time.

Figure 8. a1N of 3N Panel location in relation to mining in 2019 (Evanek et al., 2020)

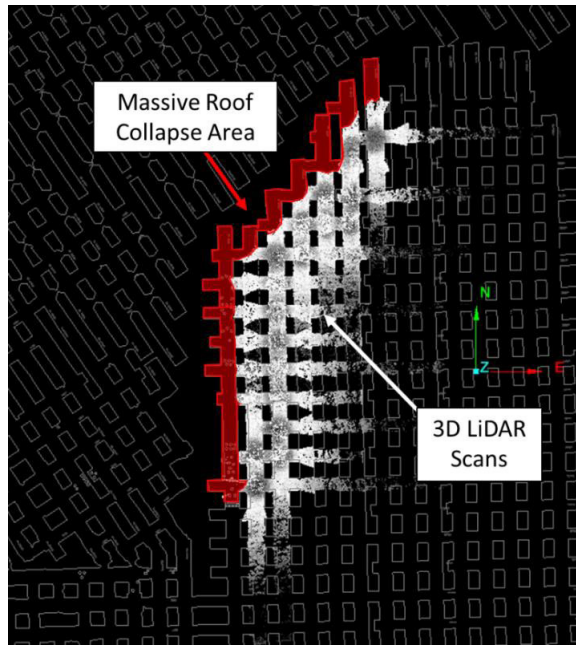
**Figure 9. 3D LiDAR pointcloud ariel image of massive roof collapse**

Baseline 3D LiDAR scanning of the collapse area was conducted in July of 2022. Scans were captured using the Maptek I-Site 8200 stationary scanner, and 360-degree scans were collected at each entry and crosscut along the collapse area approximately 50 ft apart. Each scan was then registered to each other using Maptek's PointStudio program and georeferenced to the Subtropolis Mine map. This allowed researchers to visualize the collapse area (Figure 9).
