# Best Practices for Ensuring Safety in Field Studies: A Comprehensive Guide for Mining Researchers and Operators

## ABSTRACT

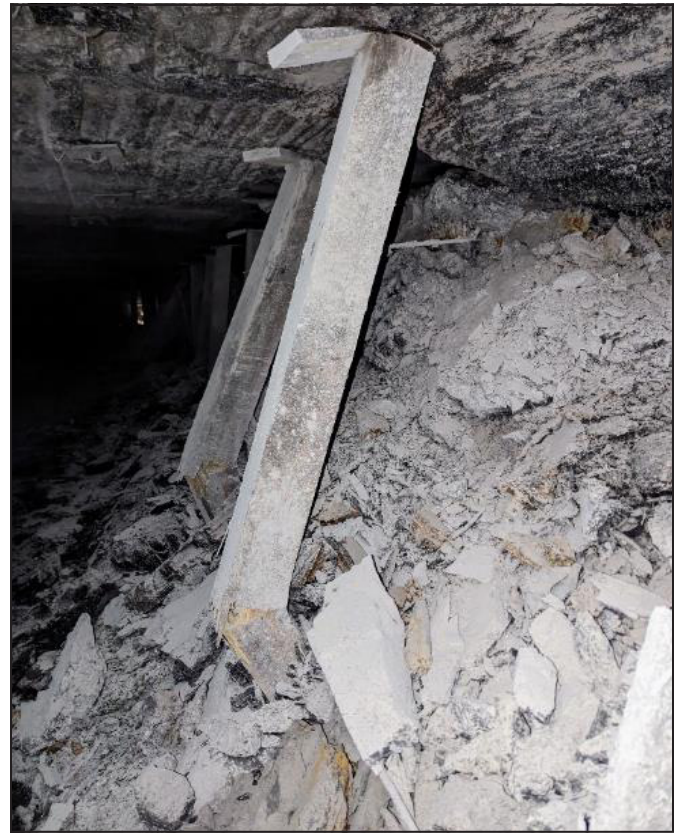
**Figure 1. Example of potential rib hazards including rib sloughage and damaged supports**

In underground mining, roof and rib falls are serious safety concerns. These falls happen when the roof or walls of the mine become unstable due to factors like stress, changes in lithology, and weathering effects. These incidents have the potential to injure both mine researchers and operators. These hazards include loose or detached material from the roof or rib, rib brows due to excessive sloughing, and potentially damaged supports.

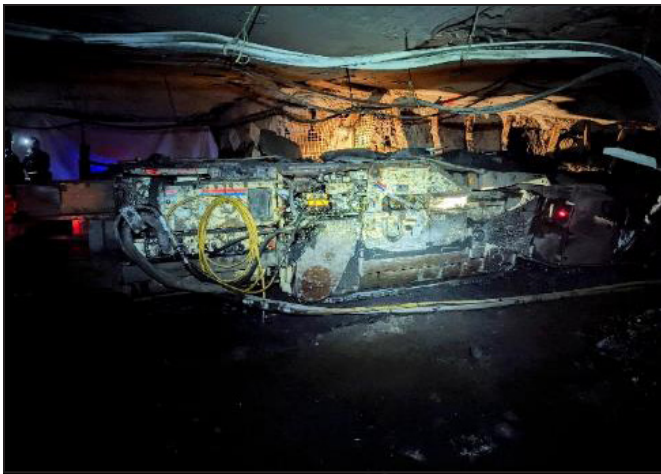
**Figure 2. Example of tramming a continuous miner representing a potential struck-by hazard**

Struck-by hazards also represent a significant proportion of hazards encountered underground. There are numerous different pieces of heavy equipment and machinery moving underground. The combination of moving and repositioning of heavy equipment (roof bolters, continuous miners, shuttle cars, man trips, etc.), poor visibility, and confined working conditions can subject researchers to struck-by hazards (See Figure 2).

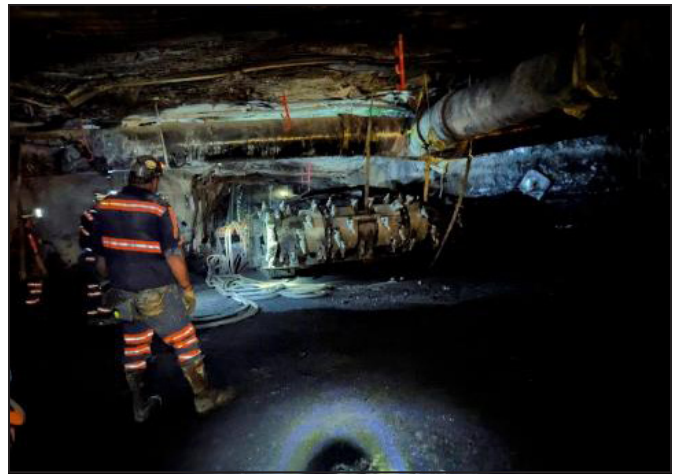
**Figure 3. Example of a tramming continuous miner depicting the tight spaces associated with underground equipment and potential for caught between hazards**

The underground environment can present tight conditions with the addition of working in close proximity to heavy equipment which means that caught in/between hazards are also present (See Figure 3). Additionally, some underground equipment have pinch points associated with them, particularly scoops, and conveyor belts have multiple moving components that are capable of being caught in.

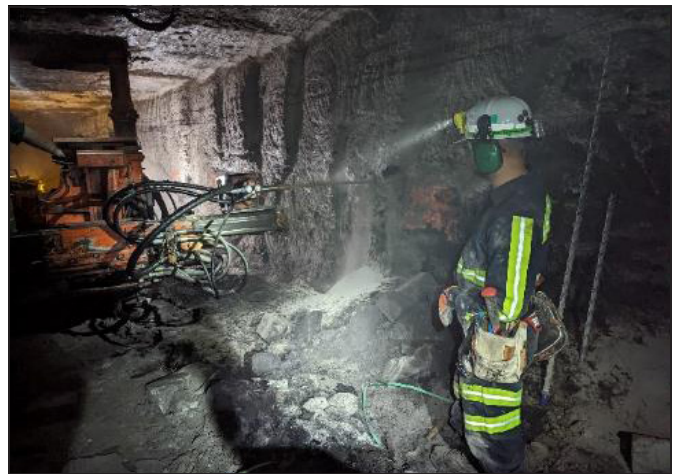
**Figure 4. Example of drilling operations resulting in the production of dust**

A prime example of researchers potentially being exposed to respiratory hazards would be during data collection, particularly in longwall tailgates and other return air courses. The final data collection and data logger retrieval at a longwall mine in Central Utah is a recent example where this hazard was encountered by NIOSH researchers (Minoski et al., 2020). In this case, researchers were required to traverse the tailgate as it was not accessible from the longwall face. This occurred during the mine-through of a fault resulting in increased exposure to dust from cutting the surrounding rock.

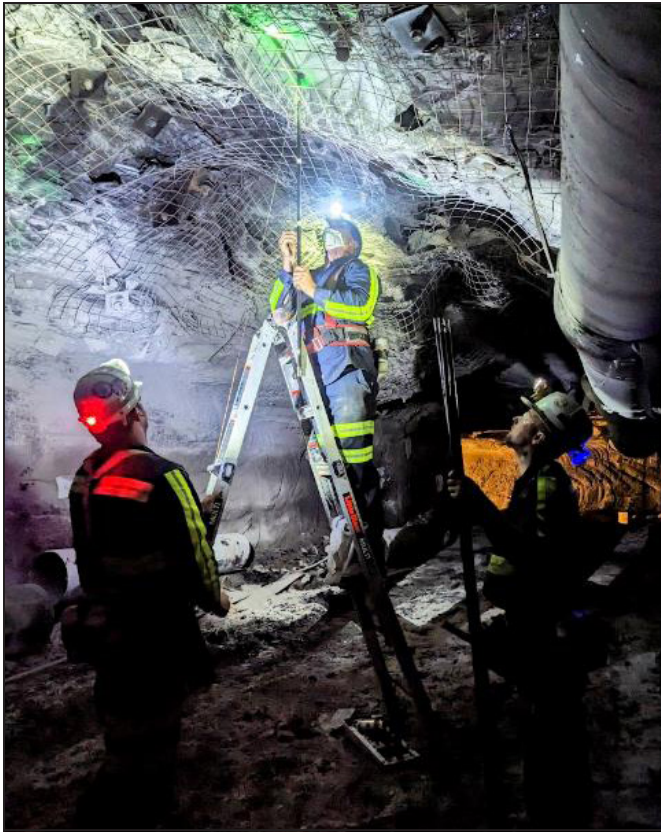
**Figure 6. Photo depicting researchers safely using a ladder to install instrumentation**

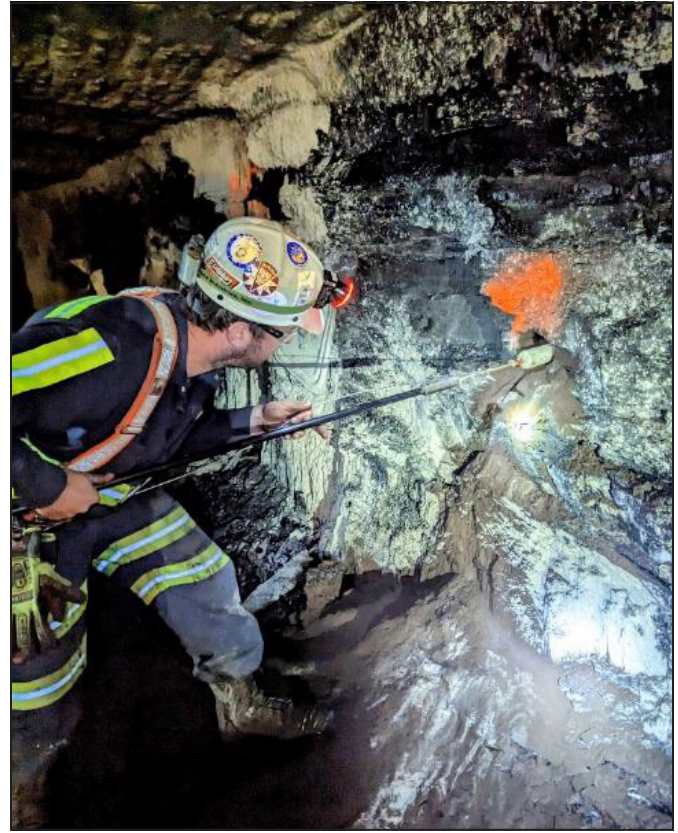
**Figure 7. Photo depicting a researcher beginning the installation of a BPC using a set of insertion/setting rods**

Following completion of boreholes being drilled, the BPCs are now ready to be installed. This stage carries additional hazards that can affect researchers during installation. Insertion rods are utilized to install the BPC itself into the borehole. Researchers must connect these pieces together to

be able to set the BPC at the maximum depth of the hole (See Figure 7).

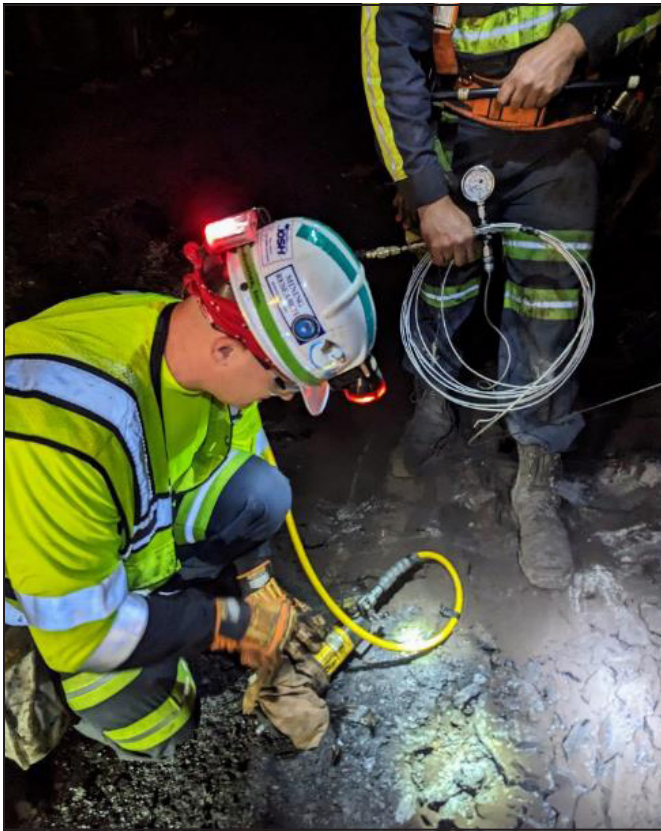
**Figure 8. Photo of a researcher pressurizing the BPC to its initial setting pressure using a hydraulic pump**

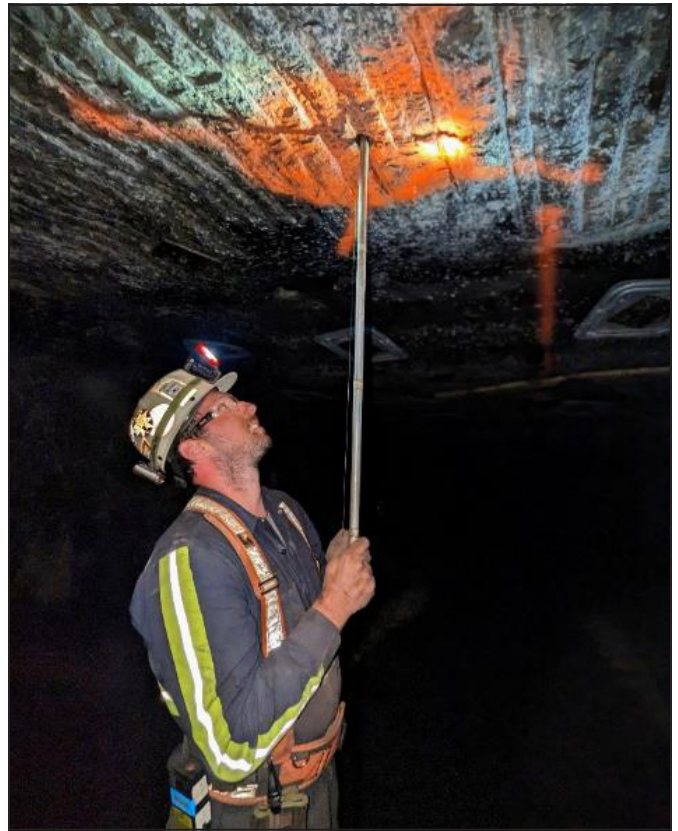
**Figure 9. Photo of a researcher beginning the process of installing anchors for a roof extensometer**

As previously noted with the use of insertion rods for BPCs, hand injuries and pinch points are a major concern when connecting or disconnecting rods (See Figure 9).

In addition to hand injuries from the insertion rods, the anchors have stainless steel wire connected to them. Hand injuries (cuts, abrasions, etc.) can occur while tensioning the wires during installation.

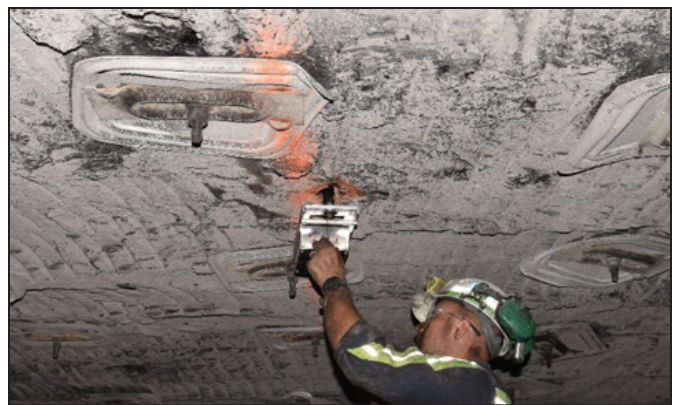
**Figure 10. Photo of a researcher completing the installation of a roof extensometer using epoxy and wooden wedges.**

Once the anchors are set to the correct depth, installation of the extensometer device itself begins. To achieve this step, the researcher adds an adhesive to the pipe connected to the extensometer. The pipe connected to the extensometer is then placed into the drilled hole. The adhesive that is placed on the pipe has hazards associated with it, including the potential for burns if it contacts skin.

While setting the extensometer, wedges are typically utilized to ensure a snug fit in the drilled hole. Researchers

will use a hammer to set the wedges, and there is a hazard of both hand and line-of-fire injuries (See Figure 10).

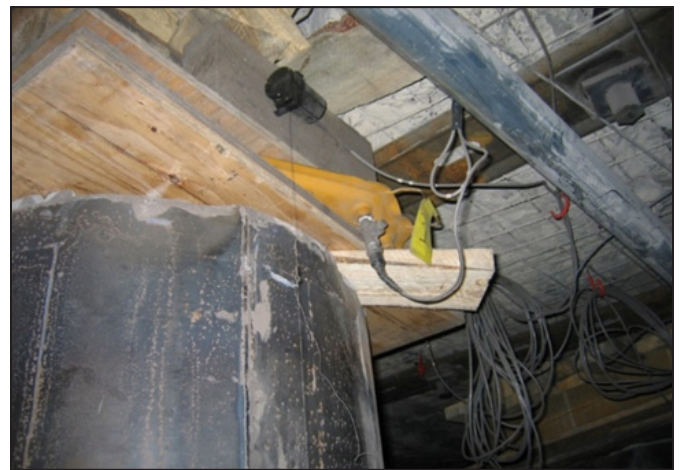
**Figure 12. An example of a standing-support load cell installed on top of a can type standing support between two sheets of plywood.**

Standing-support load cells are used to measure the loading performance of standing support in the mine (See Figure 12). Hazards associated with the installation of a standing-support load cell include manual handling hazards and slip, trip, and fall hazards.

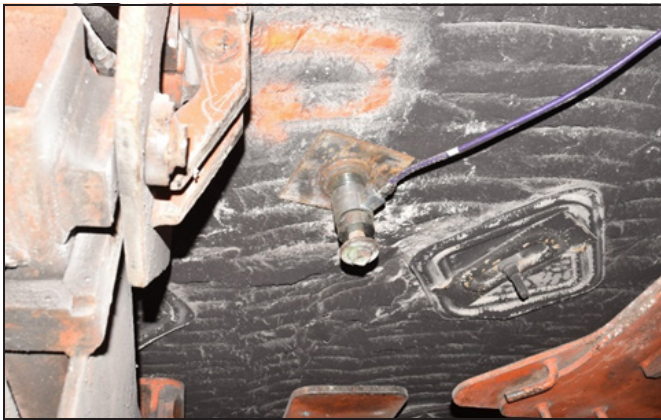
**Figure 13. Example of an installed roof bolt load cell**

Roof/rib bolt load cells are devices containing strain gauges used to measure the load on rock bolts (Minoski et al., 2024). Hazard associated with the installation of these load cells include working around heavy equipment, manual handling, and pinch points. A roof bolting machine is utilized to install the load cell. Similar to the installation of BPCs and extensometers, working in close proximity to a roof bolting machine will present the same hazards to researchers and operators. Part of the installation of cable bolt load cells involves sandwiching a 1" plate, a load cell, another 1" plate, and a roof bolt plate on a roof bolt (See Figure 13). The hazard for researchers and operators completing this task is pinch points and hand injuries.

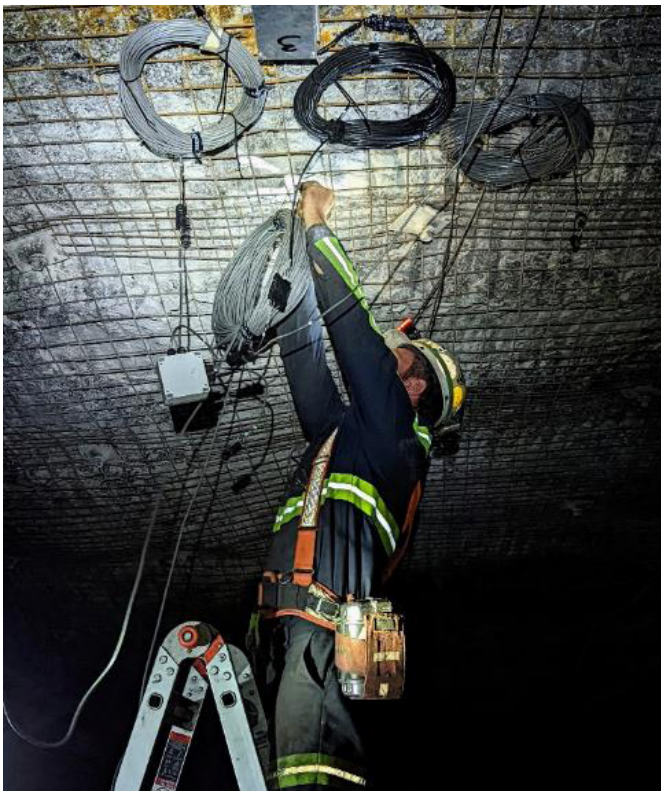
**Figure 15.** Example of a researcher safely using a ladder to hang cable from the mine roof.

Following completion of installing the required instrumentation at a field site, researchers are required to run cables from the instruments to the dataloggers located a distance outby. Cables are typically hung directly from the roof by attaching the cables to roof bolt plates or roof mesh. This ensures the cables are protected from damage by mobile equipment.

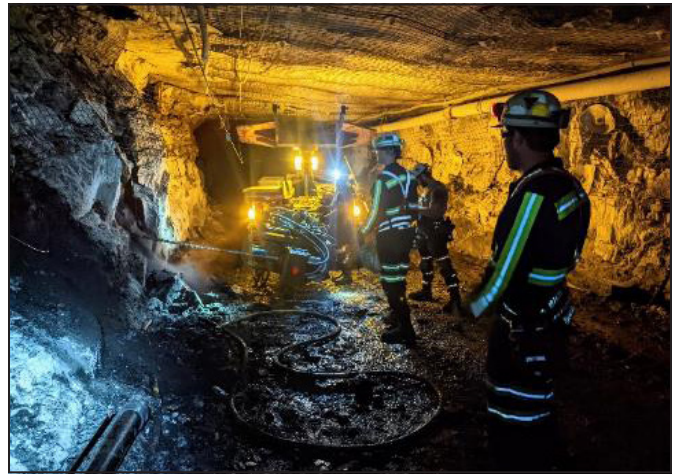
**Figure 16. Example of some slip, trip, and fall hazards including wet and uneven terrain, water line, rib sloughage**

Researchers and operators need to identify slip, trip, and fall hazards to ensure mitigation. Eliminate the hazard by removing objects and materials that can possibly cause a slip, trip, and fall (NIOSH, 2022). Plan an appropriate travel path and watch foot placement while commuting throughout the mine (See Figure 16).

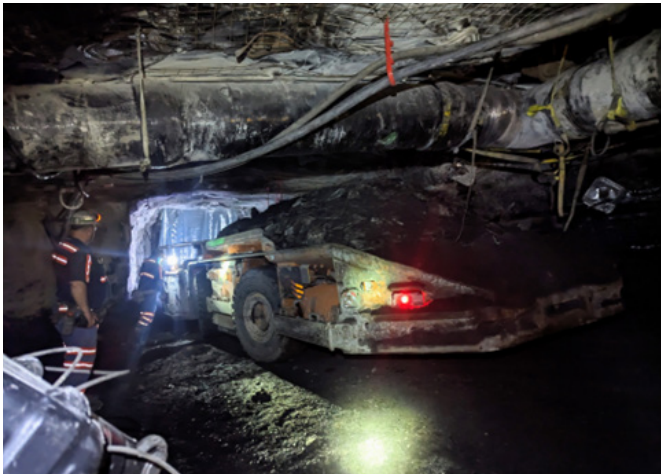
**Figure 17.** Example of a mine employee making positive contact with a shuttle car operator to inform them of additional employees and researchers working in the area

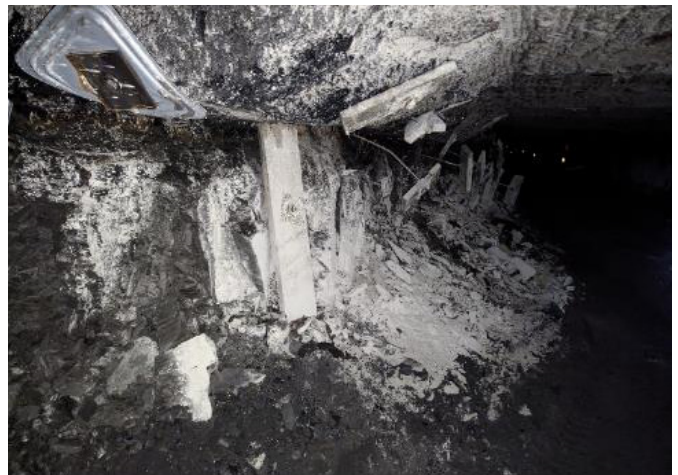
**Figure 19. Example of rib sloughage, loose rib bolts, and the potential for brow formation of a coal rib**
