# Experimental and Numerical Analysis on Failure of Soil Slopes Induced by Increasing Pore Water Pressure

## ABSTRACT

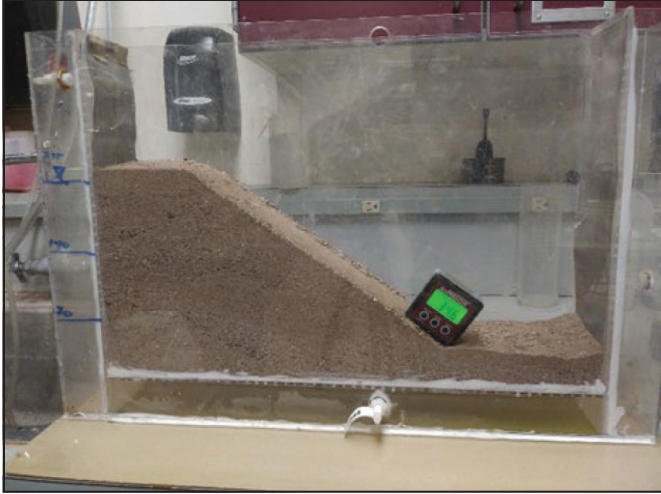
**Figure 6. Box of soil sample before gradual water rise experiment**

Experiment 2 was to raise the water level gradually until failure occurs. At a slope height of 225 mm, the initial water level was set at 70 mm. The water level is kept constant for 3 minutes and then raised a further 70 mm to 140 mm slope level for another 3 minutes. The last stage was raising and maintaining the water level steady at 215 mm high until failure. The final slope angle for the model was  $35^\circ$ . The image shown in Figure 6. is the setup for the experiment.

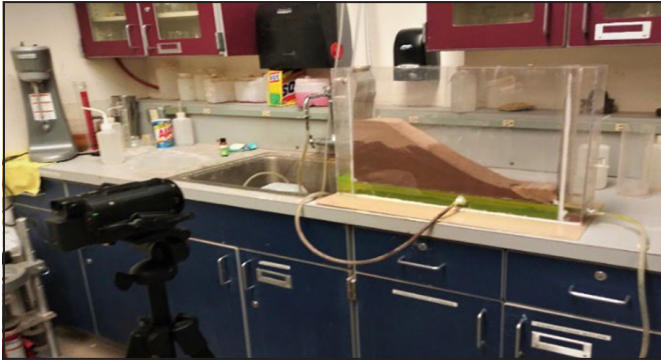
**Figure 7. Set up for experiment with the camera and dye**

The focus for the next test was mainly to study seepage in soil. In this experiment, the bottom chamber was entirely filled with water. A dye was poured in the upslope chamber and water level allowed to rise and flow through the soil slope. A night mode is set and an ultraviolet (UV) flashlight flashed along the water path through the soil (Figure 7). The use of the dye would help tracing the water path as it moves through the soil. Since a night mode is simulated, the UV flashlight was able to detect its path. Finally, a 4K camera is set to film the process for further studies.

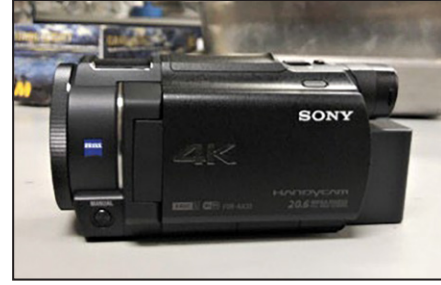
**Figure 8. The camera for digital video recording**

A camera was set up to monitor the seepage front using a 4K camera and a dye. The camera recorded the saturation process for seepage and slope movement throughout the experiment. These processes were then compared to the numerical modeling results. The camera was a Sony AX33 4K Handycam (Figure 8). Table 1 shows the technical specifications of the video camera.

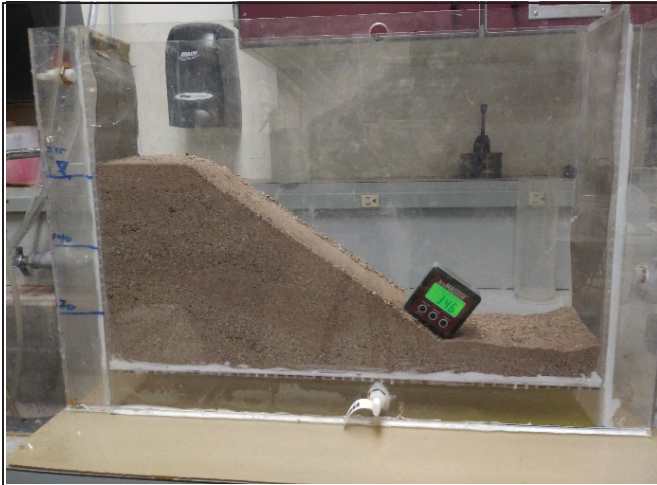
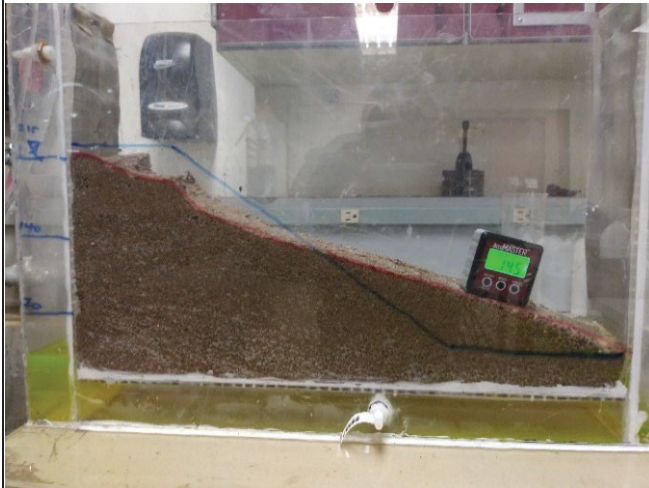
**Figure 10. Experiment of gradual water rise (a) before failure (b) after failure**

The second experiment was a gradual rise in water level to induce slope failure. The water level was kept constant for 3 minutes at each level before rising to the next level. Failure occurred at the last stage when the soil sample was fully saturated.

A comparison of the slope geometry before and after is shown in Figure 10).

Firstly, the settlement of the crest of the slope is attributed to the wetting-induced collapse of the saturated area close to the toe. Along with Jia et al. (2009), other research by Tadepalli et al. (1992) also observed a similar wetting-induced collapse where a volumetric strain of 1.1% was measured for the settlement. In this experiment, a 9% settlement was measured. The original slope angle of  $35^\circ$  was reduced to  $20^\circ$  after the failure occurred.

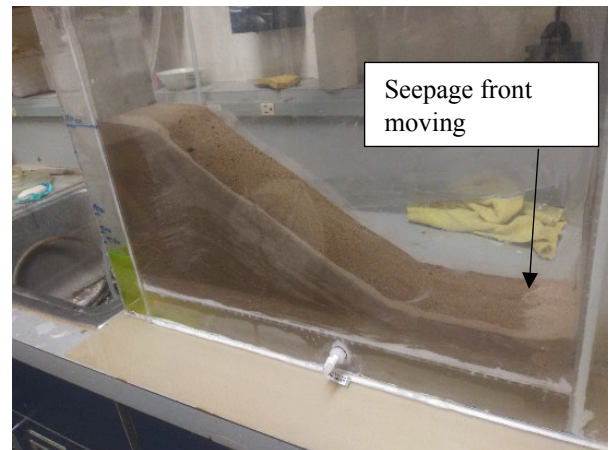
Figure 14. Transient seepages of all stages (continues)

The next two experiments looked at seepage without water in the bottom chamber since the base was sealed watertight. In the initial condition, water was allowed to fill the left chamber almost to the level of the slope and kept constant for 5 minutes. The water was then allowed to drawdown and drain through the soil. A transient analysis was then conducted in Rocscience Slide to compare that of the experiment. The analysis showed a gradual seepage front movement. During the last stages, the change was very insignificant hence the difficulty of seeing the difference in the seepage front (Figure 14).

The figure shows the movement of the seepage front with time through the soil sample. The contours show pore pressures with blue being the highest to the least of red color.
